# Village Walk Lake Bank Assessment

28041 Eagle Ray Ct Bonita Springs, FL 34135

Date Wed 06/09/2021

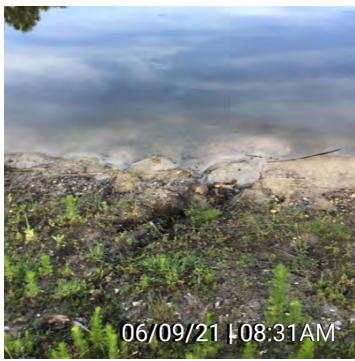
1. Figure 1 - Washout with adjacent rills to south. Correct Drop off greater than 9"

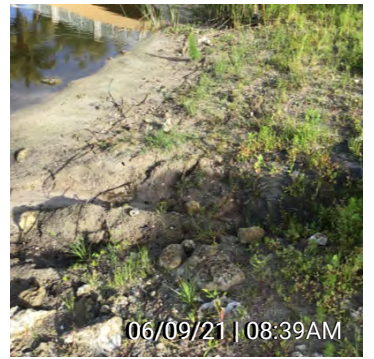
**2. Figure 2 - Minor Rilling and washout previously stabilized with riprap that has been washed out**

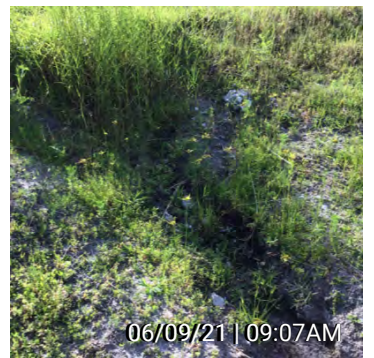
**3. Figure 3- Washout**

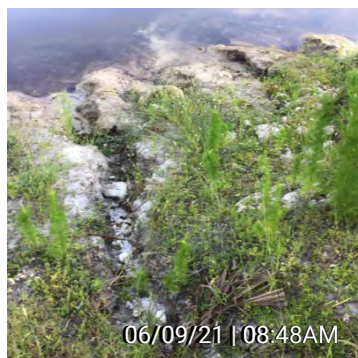
#### 4. Figure 4 - Multiple Washouts due to Rilling and Gullies

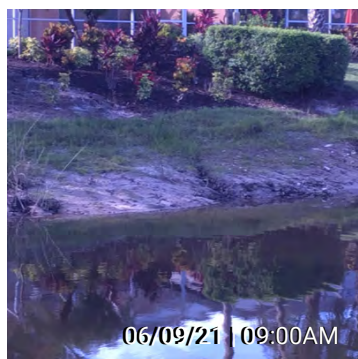
#### 5. Figure 5 - Washout (Recurring)

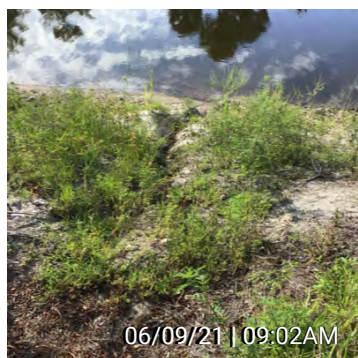
#### 6. Figure 6 - Washout

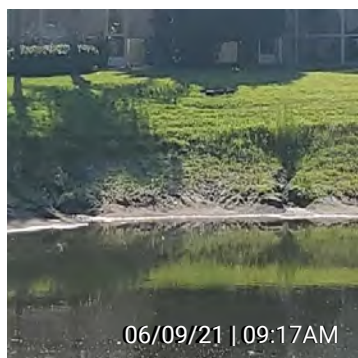
#### 7. Figure 7 - Washouts

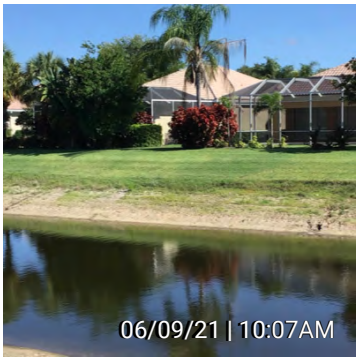
**15. Figure 15 - Minor rilling**

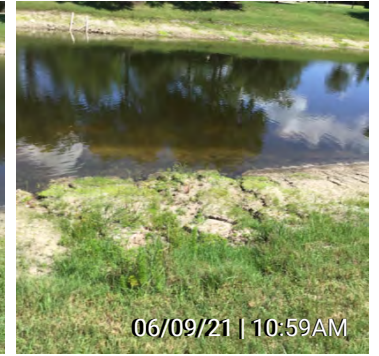
## 25. Figure 25 - Washouts and rilling

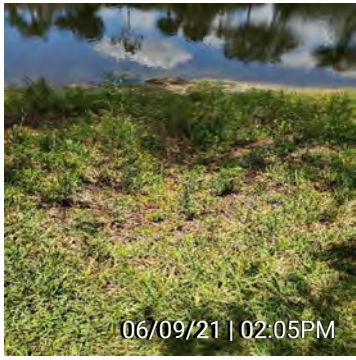
**44. Figure 44 - Deep washout**  
Dan DiVincenzo | 07/08/21 | 04:18PM

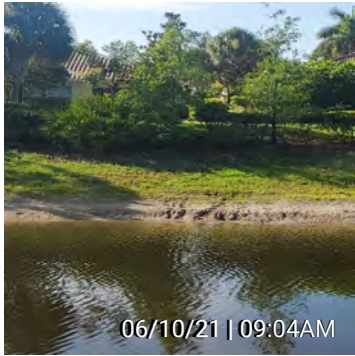
**66. Figure 66 - Erosion at lake bank**

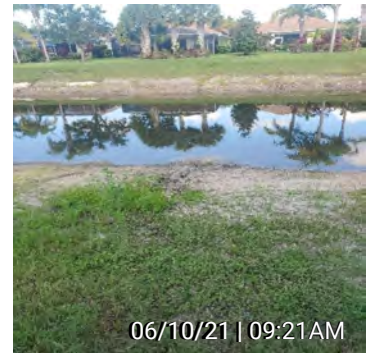
**68. Figure 68 - Washout with drop greater than 9"**

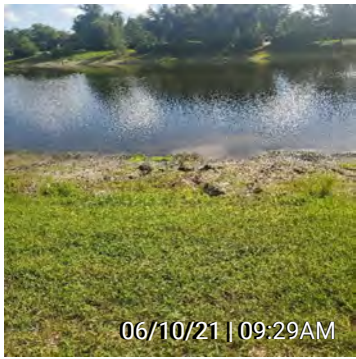
**70. Figure 70 - Washout**  
Dan DiVincenzo | 07/08/21 | 03:32PM

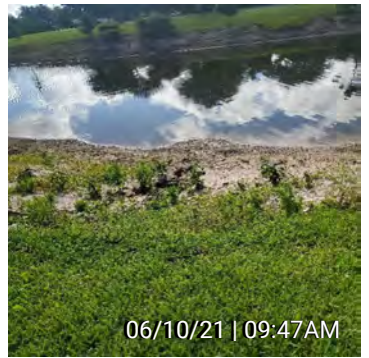
**72. Figure 72 - Washouts**  
Dan DiVincenzo | 07/08/21 | 03:30PM

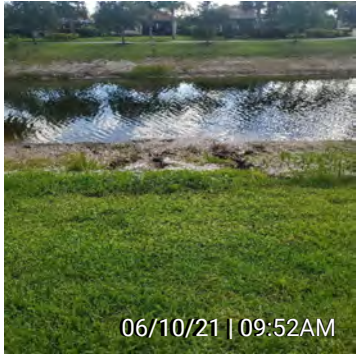
**73. Figure 73 - Washout**

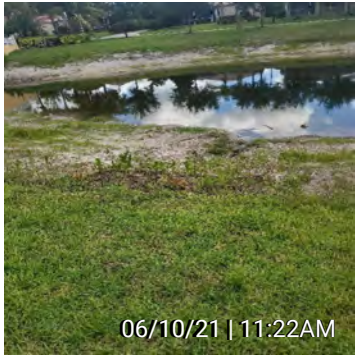
**81. Figure 81 - Washout**

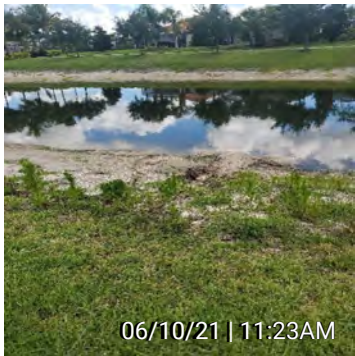
**82. Figure 82 washout caused by drop off greater than 9"**

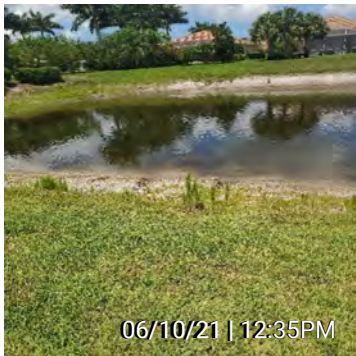
#### 96. Figure 97- Washout
