Village Walk Lake Bank Assessment

28041 Eagle Ray Ct Bonita Springs, FL 34135

Date Tue 04/09/2024

Job # 050018.00.11

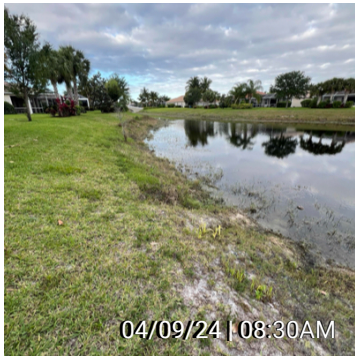
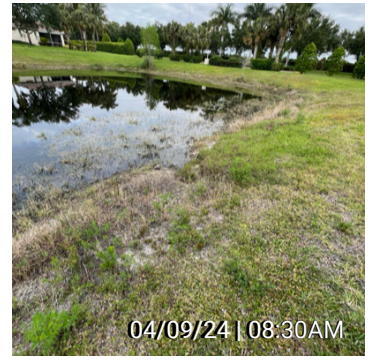
3. Lake 37 current conditions. Located washouts forming along the East side of lake. Noticed 1 aerator functioning in lake.

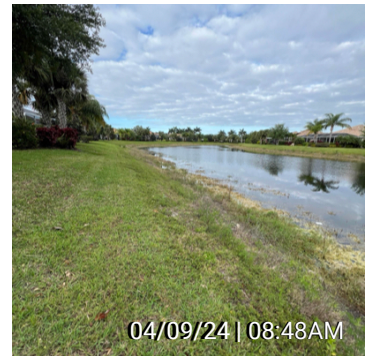
5. Lake 38 in good condition. Took pictures from the SE side of lake. Noticed 1 aerator functioning in lake.

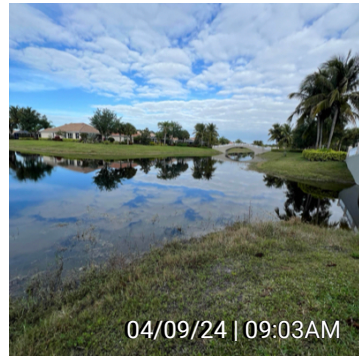
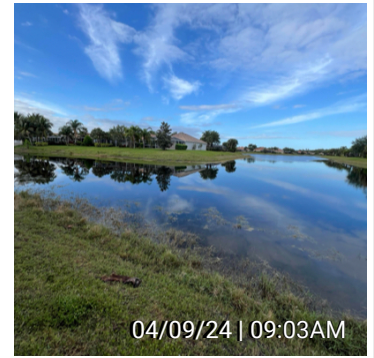
7. Lake 32 in good condition. Took pictures on the NE side of lake located by bridge between lakes 32 and 35. Did not see aerator functioning in lake.

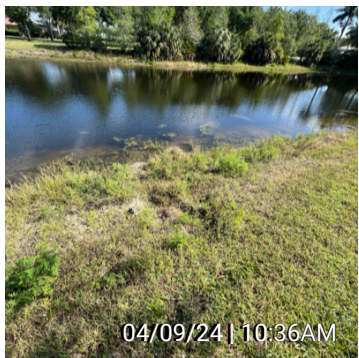
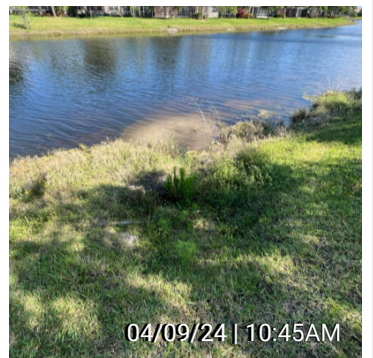
12. Lake 30 washout forming on the South side of lake. Located behind the 3rd lot of Reef Lane road. Second washout located behind the 32nd lot of Reef Lane road. Noticed 1 aerator functioning in lake.

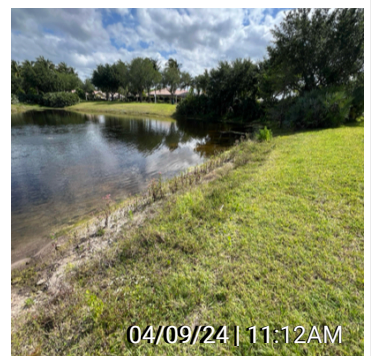
15. Lake 26 washout on the South side of lake/ stabilized over time. Noticed 1 aerator functioning in lake.
Dalton Lehnhard | 04/11/24 | 03:34PM

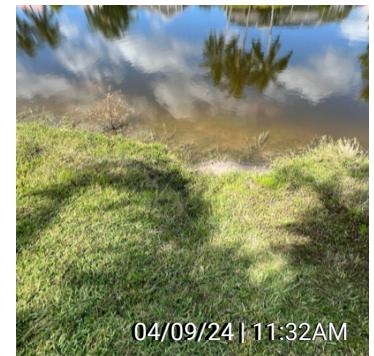
17. Lake 42 has 2 washouts located on the SW side of lake behind the 6th lot on Koi Way road. Washouts located behind the 4th and 2nd lots on Islet Trail road. Did not see functioning aerator in lake.

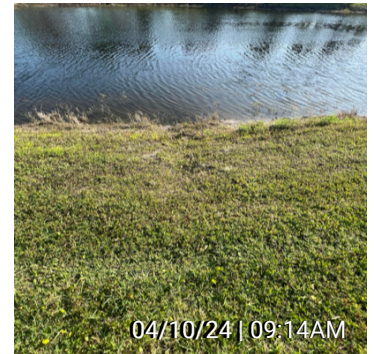
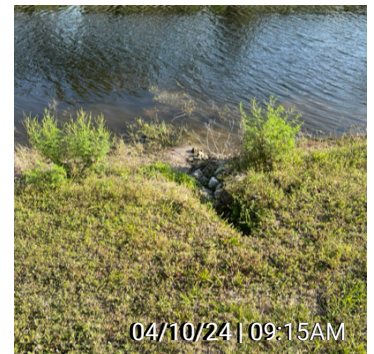
33. Lake 21 washout formed on the NE side of lake located behind the 19th lot on Danios Drive road. Washouts forming on the SW side of lake located behind the 5th and 2nd lot on Cuberra Lane road. Washout formed on the NE side of lake located behind the 12th lot on Danios Drive road and looks like homeowners added rock to prevent further damage. Noticed 1 aerator functioning in lake.

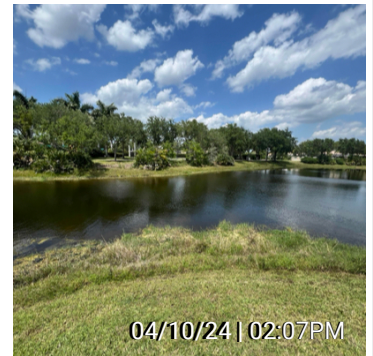
43. Lake 03 washout located by bridge that is between lakes 2 and 3 rest of lake was in good condition. Took pictures from the SW side of lake. Noticed 1 aerator function in lake.

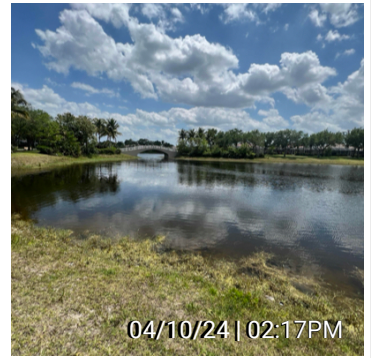
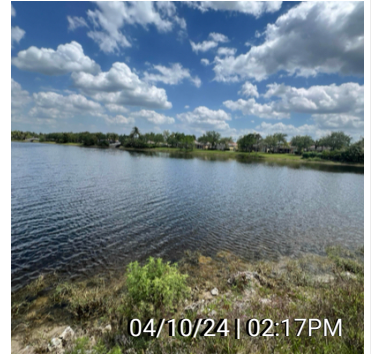
44. Lake 02 washout located by bridge that is between lakes 2 and 1, rest of lake is in good condition. Took 4 pictures from the NE corner of lake next to lake 3 and took 4 pictures on the NW corner of lake. Noticed 1 aerator function in lake. Noticed 1 aerator function in lake.

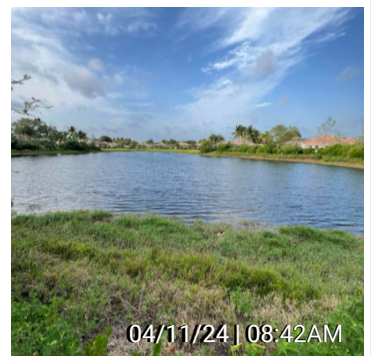
45. Lake 05 washout forming on the North side of lake located by bridge that is between lakes 05 and 02. Rest of lake is in good condition. Took pictures from the NE side of lake. Did not notice aerator functioning in lake. NOTE: tree falling at top of bank on NE side of lake located behind lots at the end of Moray Drive.
Dalton Lehnhard | 04/11/24 | 09:03AM

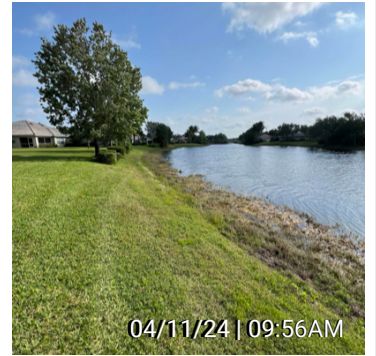
49. Lake 07 is in good condition. Took pictures from the North side of lake. Did not see aerator functioning in lake.

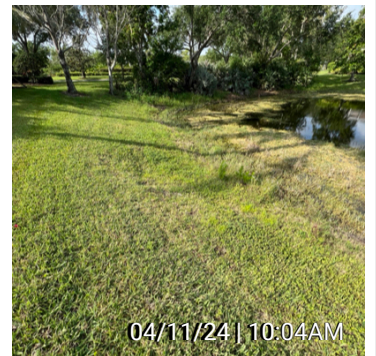
50. Lake 10 washouts formed on the SE side of lake that have stabilized with sod located behind the 2nd and 3rd lots on Scrub Jay Lane road. Noticed 1 aerator functioning in lake.
