Village Walk Lake Bank Assessment

28041 Eagle Ray Ct Bonita Springs, FL 34135

Date Tue 04/09/2024

Job # 050018.00.11

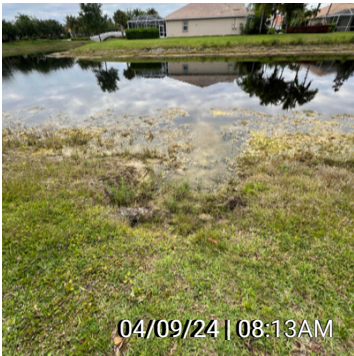
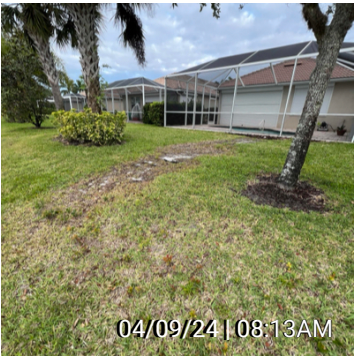
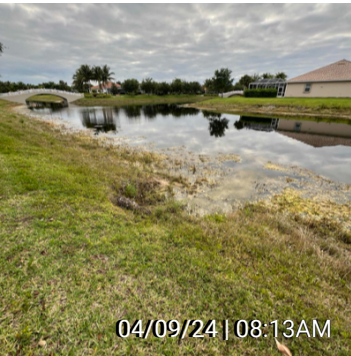
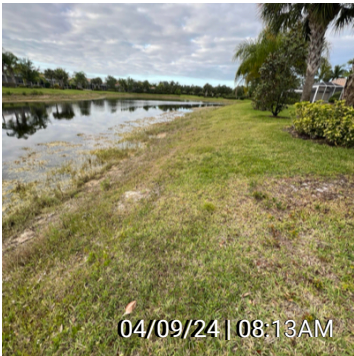
1. Lake 39. Washout occurring on the NW side of lake located behind the 4th lot down from the bridge occurring from pool drain and located bigger existing washout/ same location. Noticed 1 aerator functioning in lake.

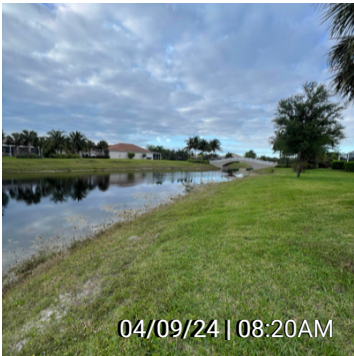
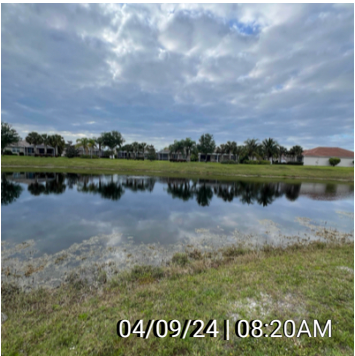
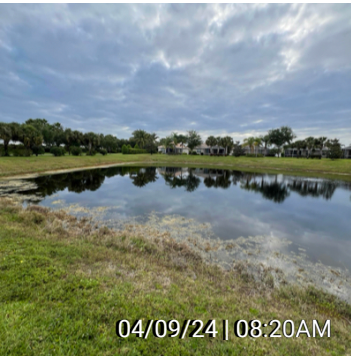
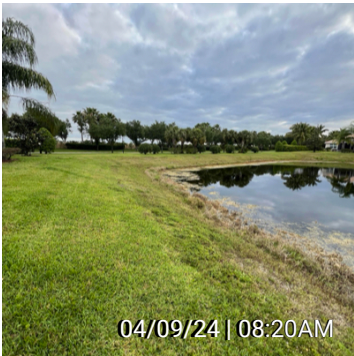
2. Lake 40 in good condition. Took pictures from the West side of lake. Noticed one aerator functioning in lake.

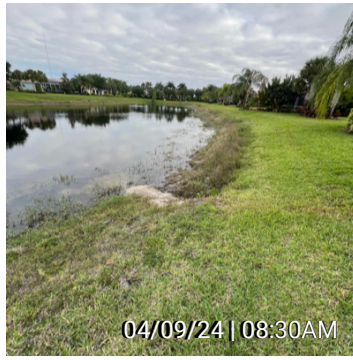
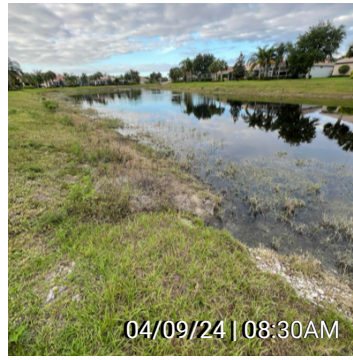
3. Lake 37 current conditions. Located washouts forming along the East side of lake. Noticed 1 aerator functioning in lake.

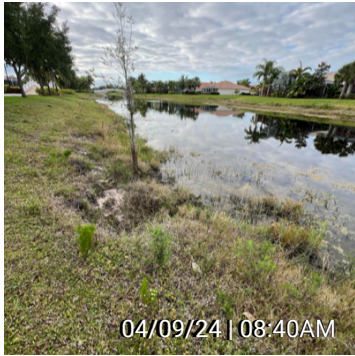
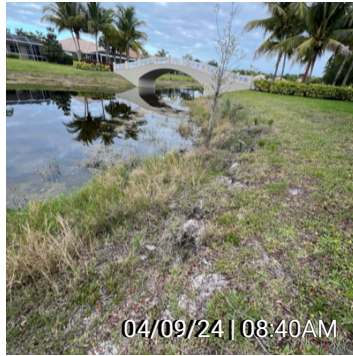
4. Lake 36. Washout forming on the NE side of lake located by bridge between lakes 36 and 39. Noticed one aerator functioning in lake.

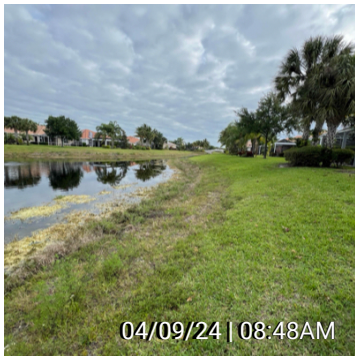
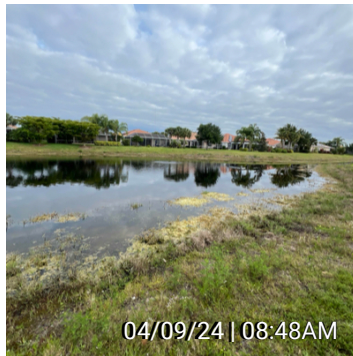
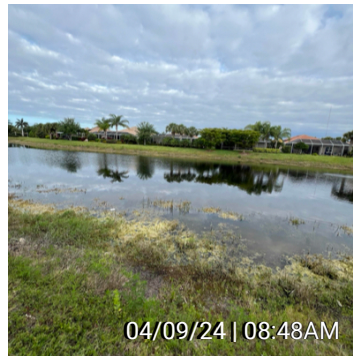
5. Lake 38 in good condition. Took pictures from the SE side of lake. Noticed 1 aerator functioning in lake.

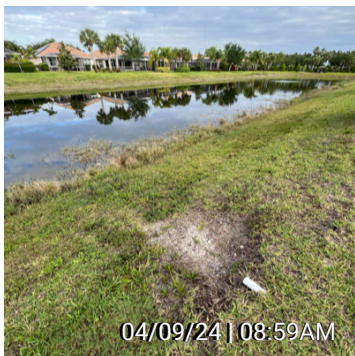
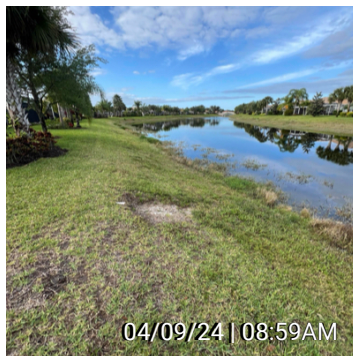
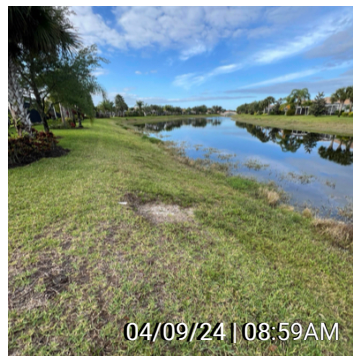
6. Lake 35 washout forming from pool drain located on the West side of lake behind 8th lot on Quiet Water Way road. Noticed one aerator functioning in lake.

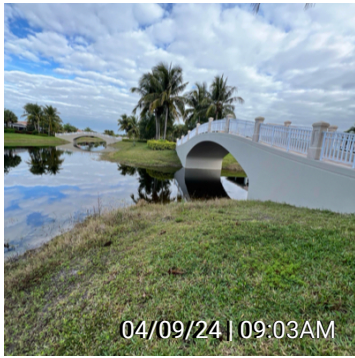
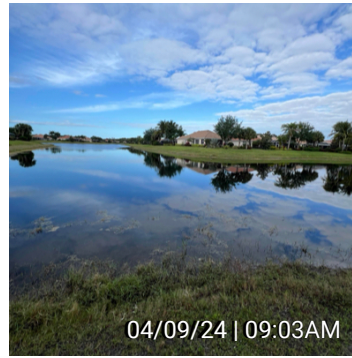
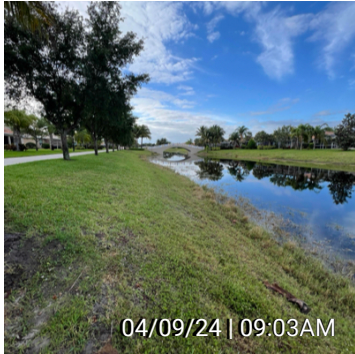
7. Lake 32 in good condition. Took pictures on the NE side of lake located by bridge between lakes 32 and 35. Did not see aerator functioning in lake.

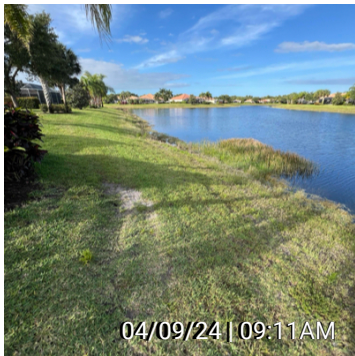
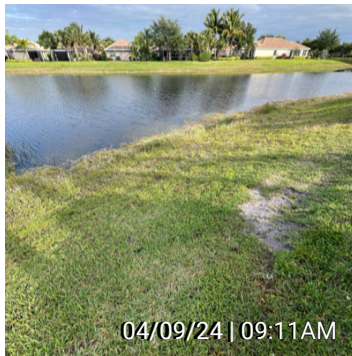
- 8. Lake 33 washout beginning to form located on the SE side of lake behind the 17th lot on Jewel Fish Lane. Did not see aerator functioning in lake.**

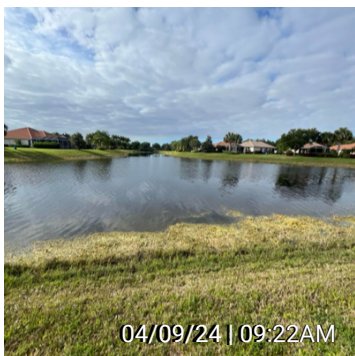
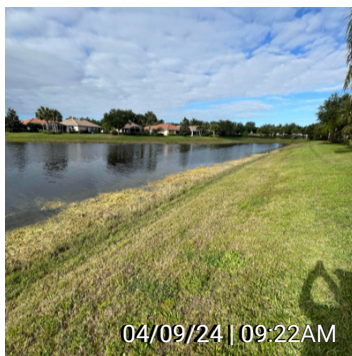
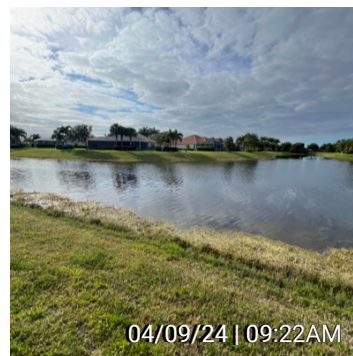
- 9. Lake 34 in good condition. Took pictures from the North side of lake. Did not see aerator functioning in lake.**

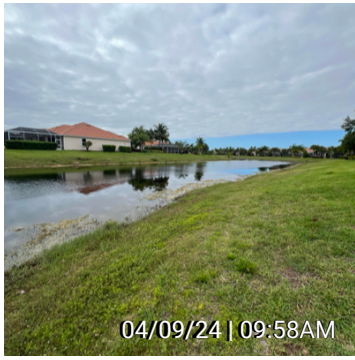
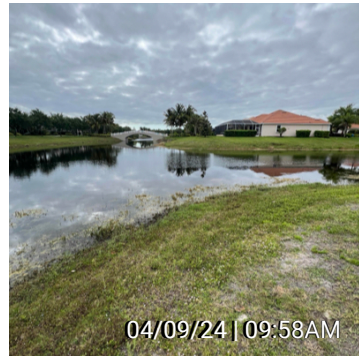
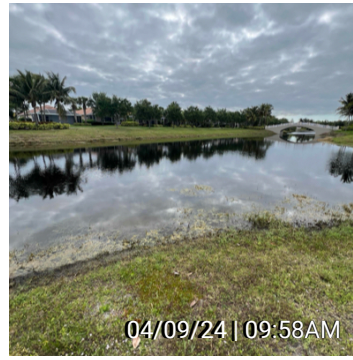
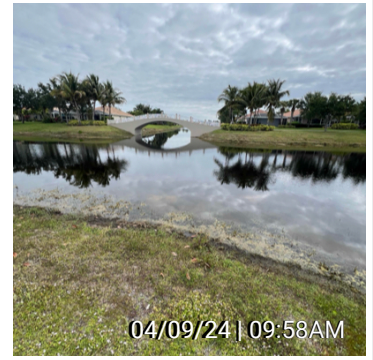
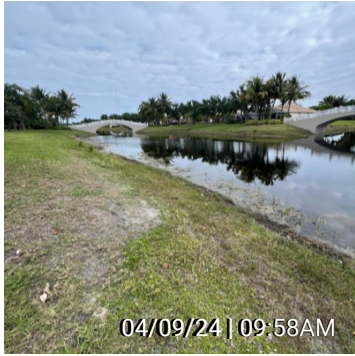
- 10. Lake 29 is in good condition. Took pictures from the NW side of lake. Did not see aerator functioning in lake.**

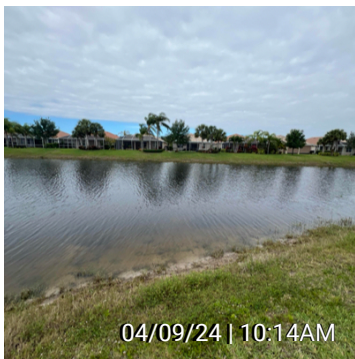
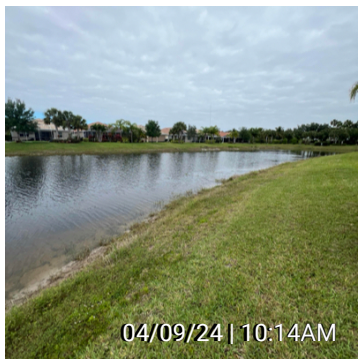
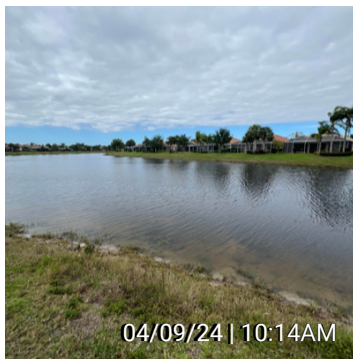
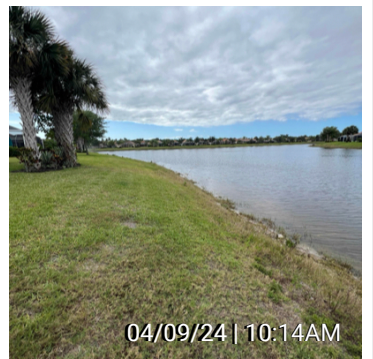
11. Lake 31 in good condition. Took pictures on the NE side of lake. Noticed 1 aerator functioning in lake.

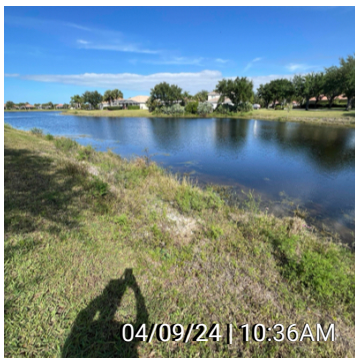
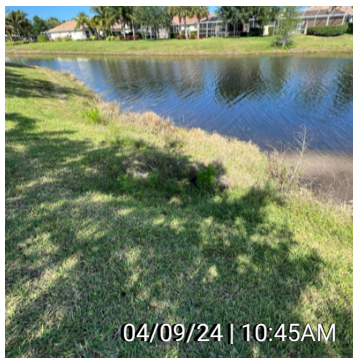
12. Lake 30 washout forming on the South side of lake. Located behind the 3rd lot of Reef Lane road. Second washout located behind the 32nd lot of Reef Lane road. Noticed 1 aerator functioning in lake.

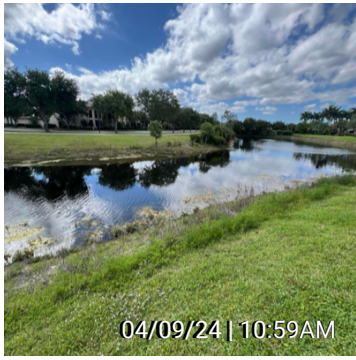
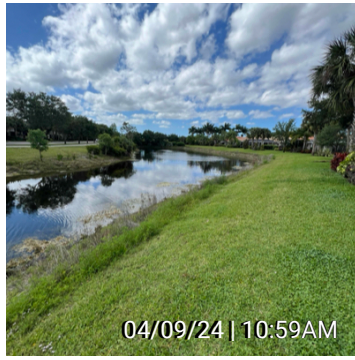
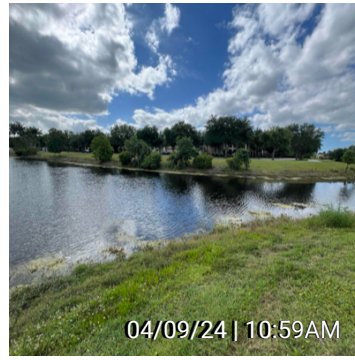
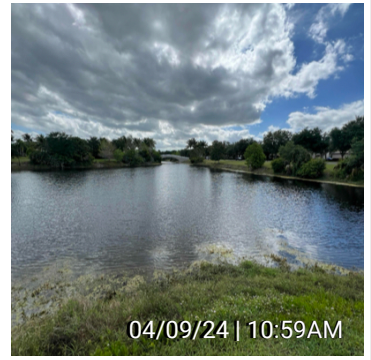
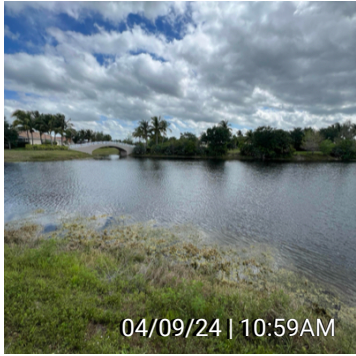
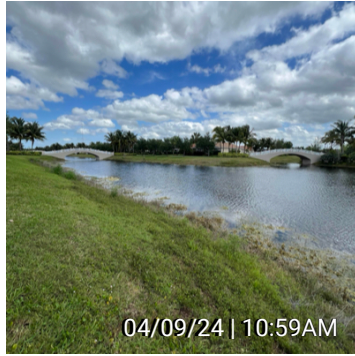
13. Lake 27 in good condition.. Took pictures from the West side of lake. Noticed 1 aerator functioning in lake

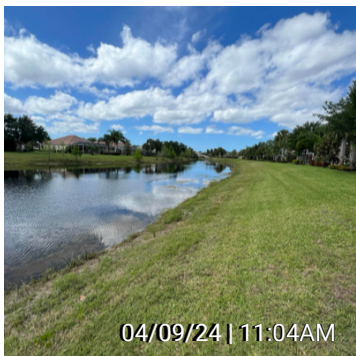
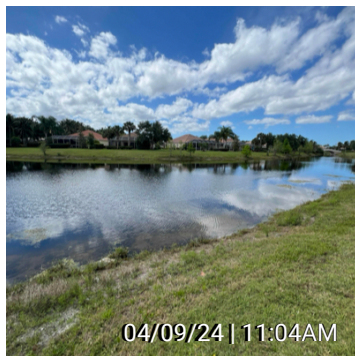
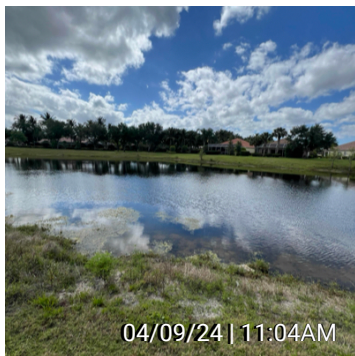
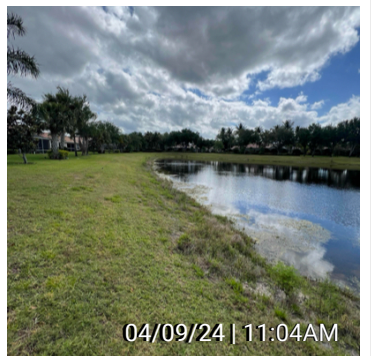
14. Lake 28 is in good condition. Took pictures from the NW side of lake. Noticed 1 aerator functioning in lake.
Dalton Lehnhard | 04/11/24 | 03:57PM

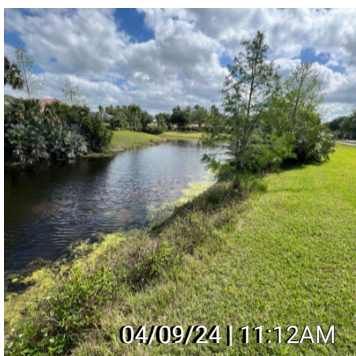
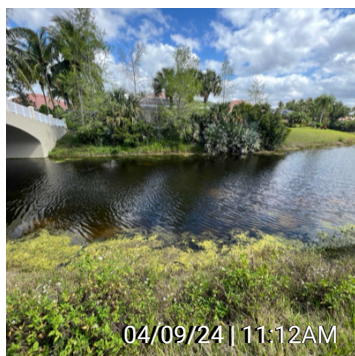
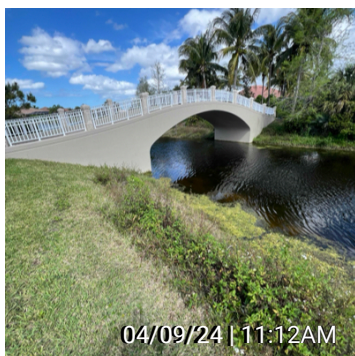
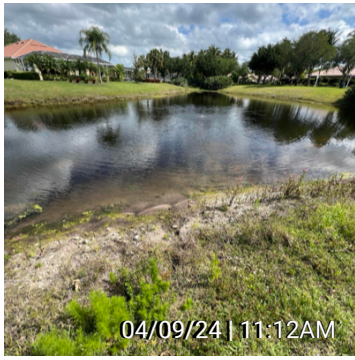
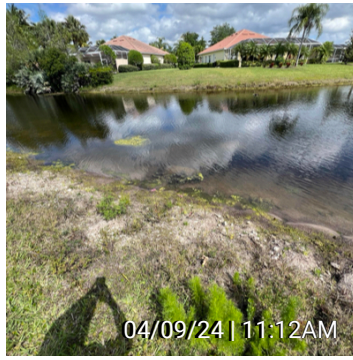
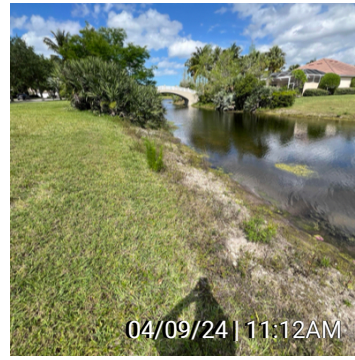
15. Lake 26 washout on the South side of lake/ stabilized over time. Noticed 1 aerator functioning in lake.
Dalton Lehnhard | 04/11/24 | 03:34PM

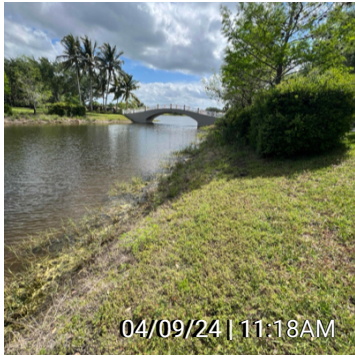
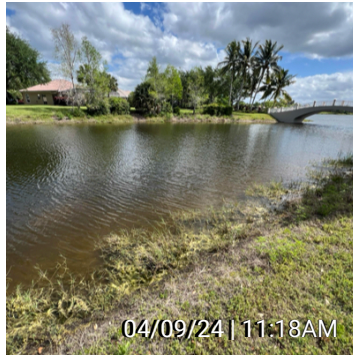
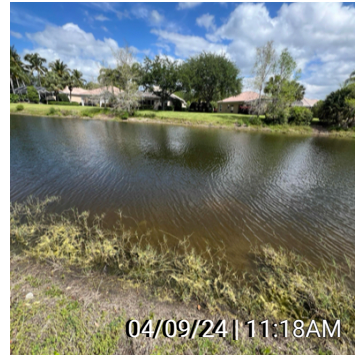
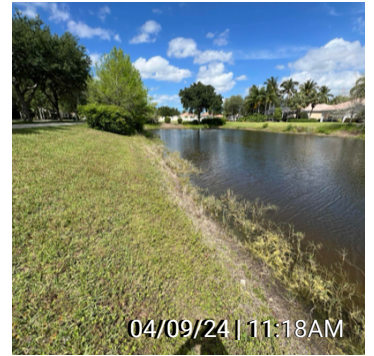
16. Lake 41 is in good condition. Took pictures from the South side of lake. Did not see aerator functioning in lake.

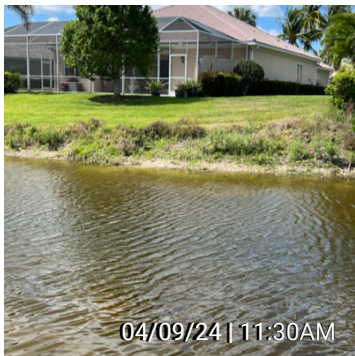
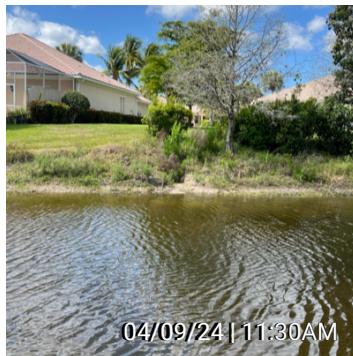
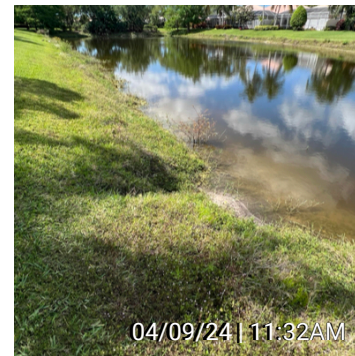
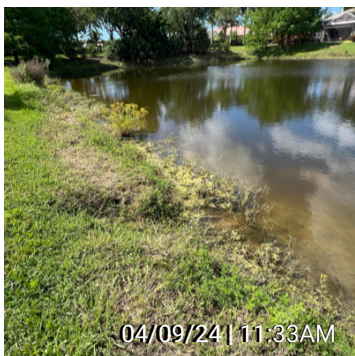
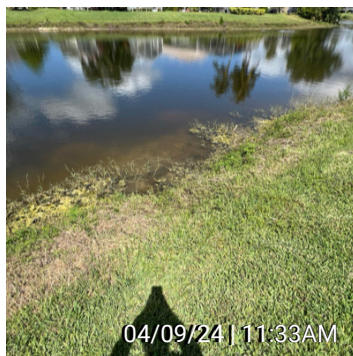
17. Lake 42 has 2 washouts located on the SW side of lake behind the 6th lot on Koi Way road. Washouts located behind the 4th and 2nd lots on Islet Trail road. Did not see functioning aerator in lake.

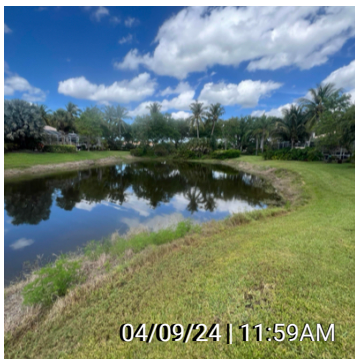
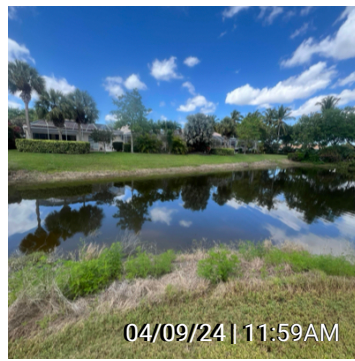
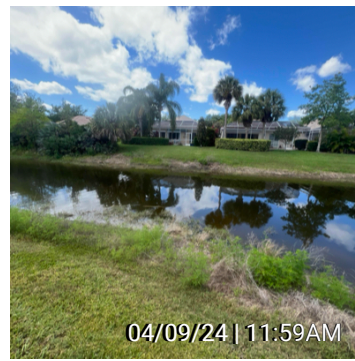
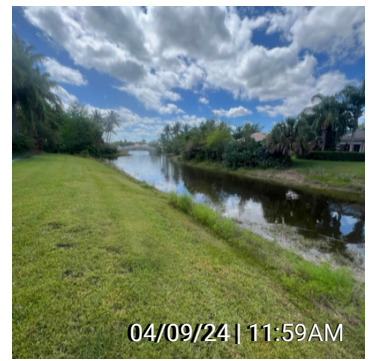
18. Lake 43 is in good condition. Took pictures from the NE side of lake. Did not see aerator functioning in lake.

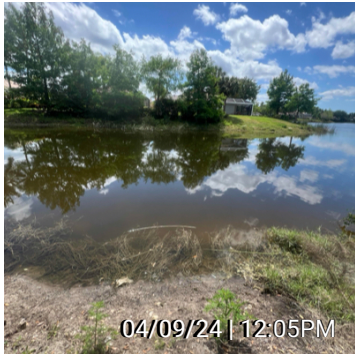
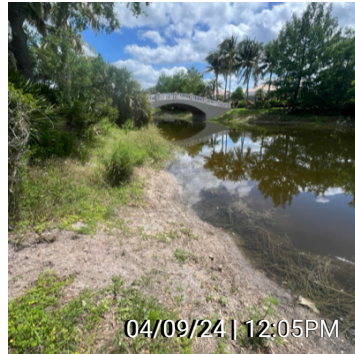
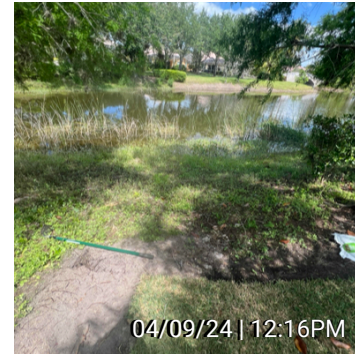
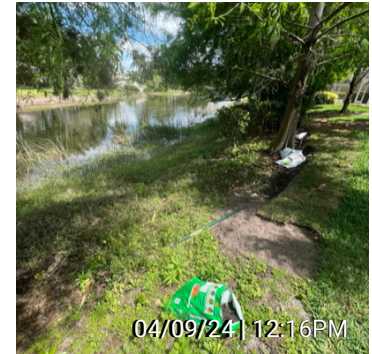
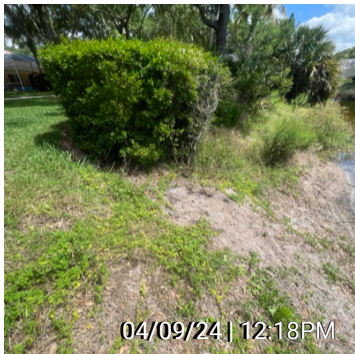
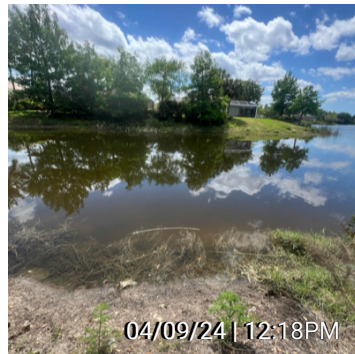
- 19.** Lake 44 area not stabilized with sod located on the North side of lake. Area may become washout if not addressed bear bridge that is located between lakes 44 and 45. Did not see aerator functioning in lake.

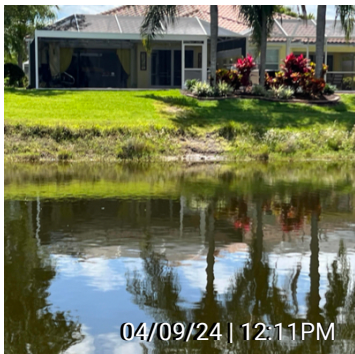
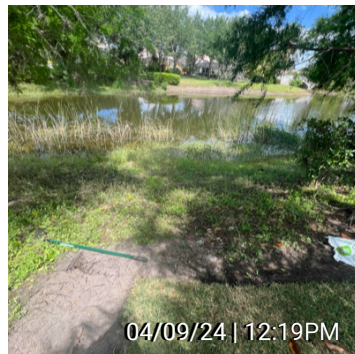
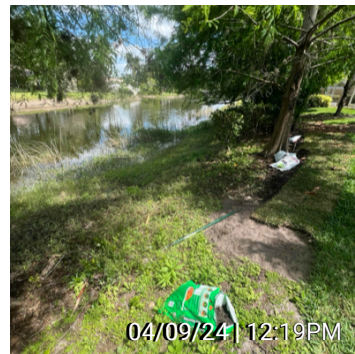
- 20.** Lake 45 washout starting to form located in the SE side of lake behind lots located at the end of Islet Trail road. Noticed area under some landscape maintenance located behind middle lot at end of Islet Trail road. Ensure area is fully stabilized with sod so no future washouts can occur. Noticed 1 aerator functioning in lake.

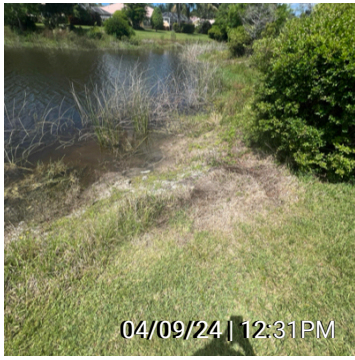
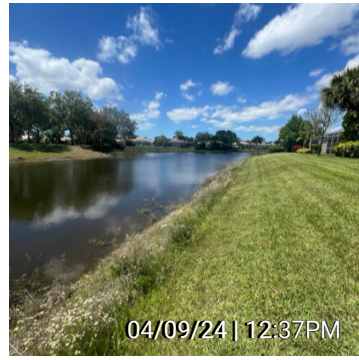
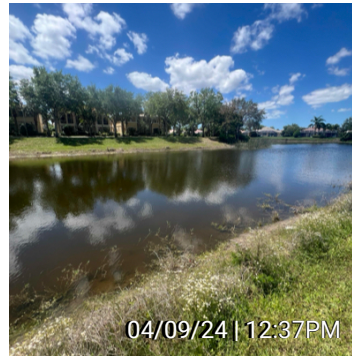
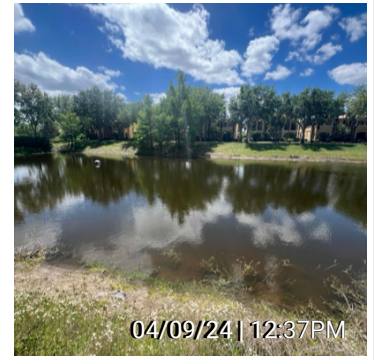
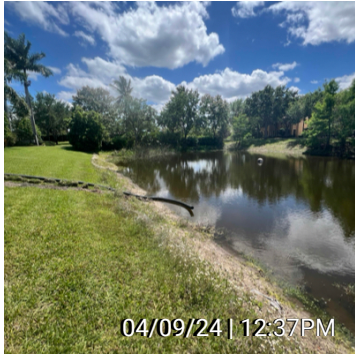
- 21.** Lake 47 small washout formed behind the 15th lot located on Herring Way road. Ground has stabilized. Took pictures from the NE side of lake. Storm yard drain getting installed on the NE side of lake located behind the 3rd lot on Herring Way. Did not see aerator functioning in lake.

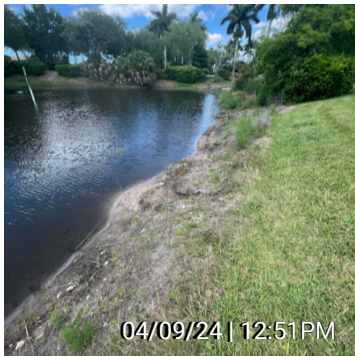
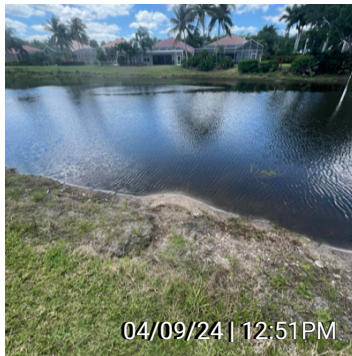
22. Lake 46 washout forming on the NE side of lake located behind the 1st lot on Darado Drive road. Noticed 1 aerator functioning in lake.

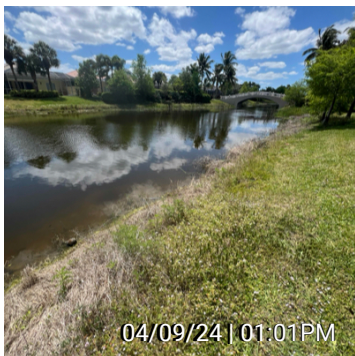
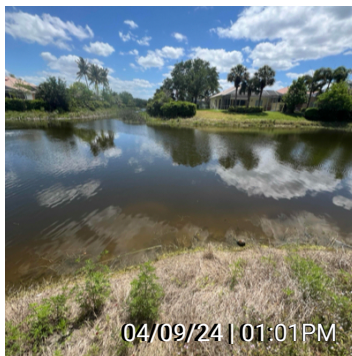
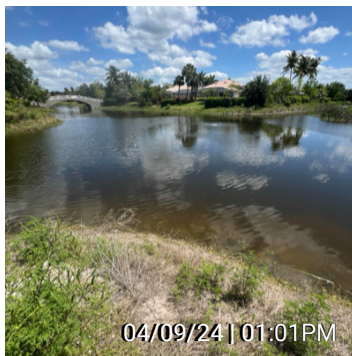
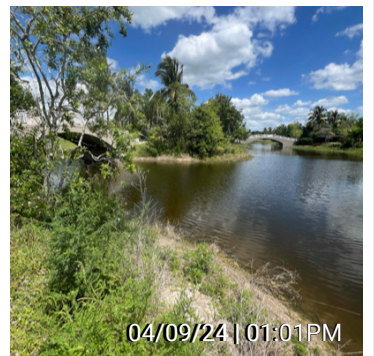
23. Lake 48 is in good condition took pictures from the NW side of lake. Noticed 1 aerator functioning in lake.

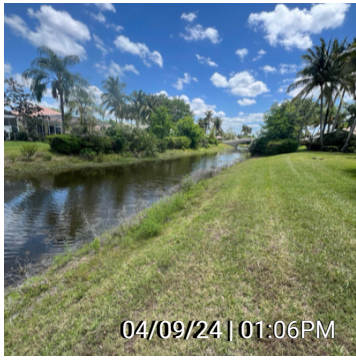
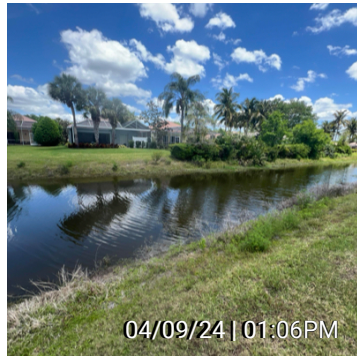
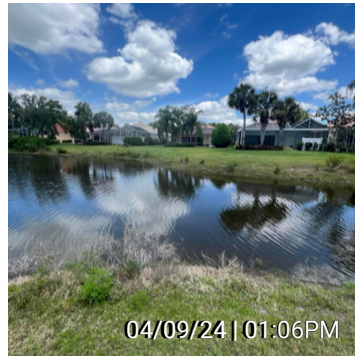
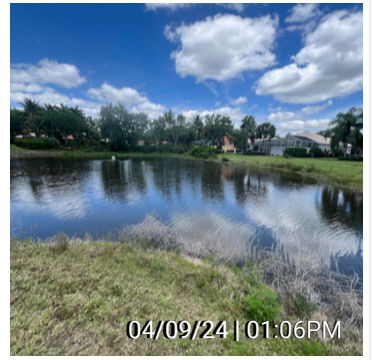
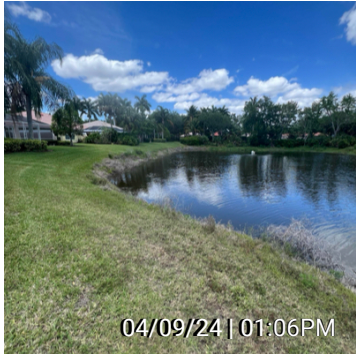
24. Lake 50 is in good condition. Took pictures from the West side of lake. Noticed 1 aerator functioning in lake.

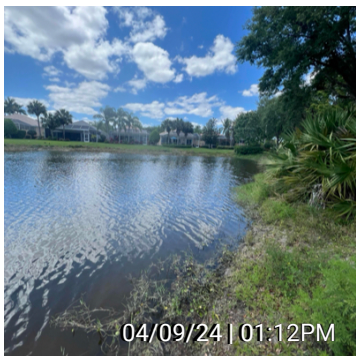
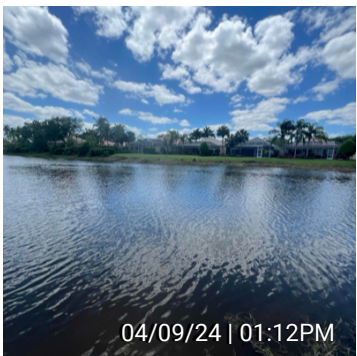
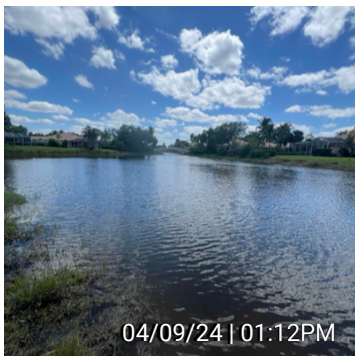
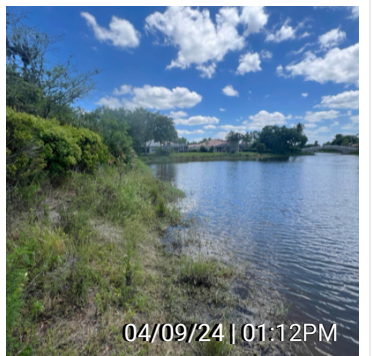
25. Lake 51 in good condition. Took pictures from the North end of lake. Noticed 1 aerator functioning in lake.
Dalton Lehnhard | 04/11/24 | 04:06PM

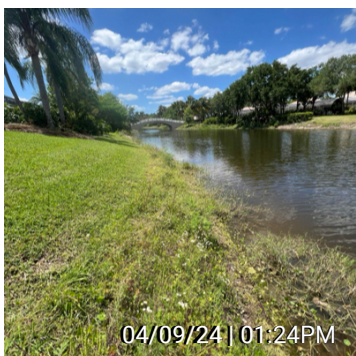
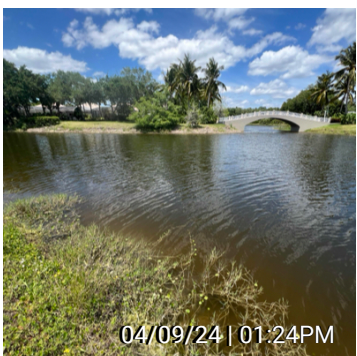
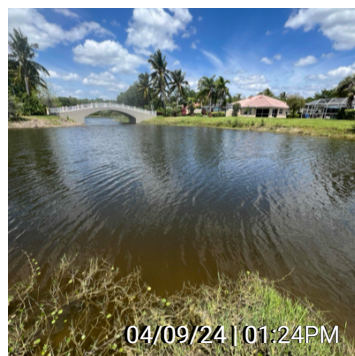
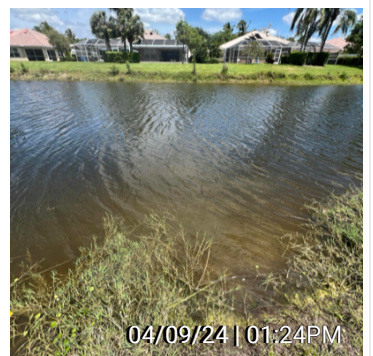
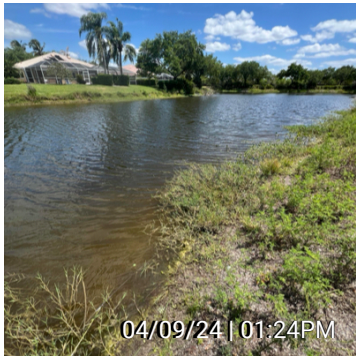
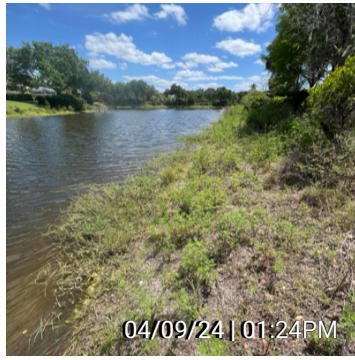
26. Lake 52 is in good condition. Took pictures from the SW side of lake. Noticed 1 aerator functioning in lake.
Dalton Lehnhard | 04/11/24 | 04:06PM

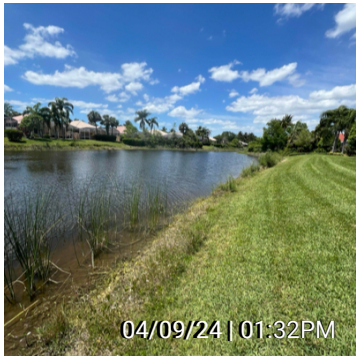
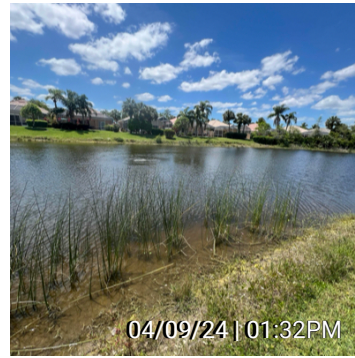
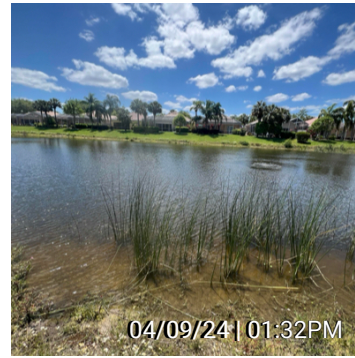
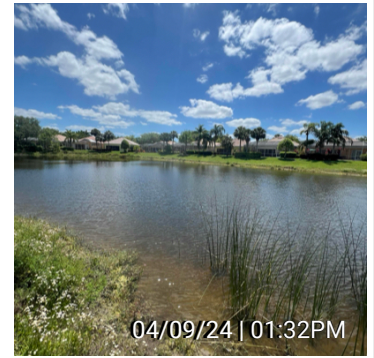
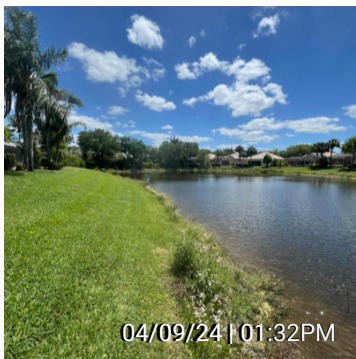
27. Lake 49 is in good condition. Took pictures from the NE side of lake. Noticed 1 aerator functioning in lake.
 Dalton Lehnhard | 04/11/24 | 04:06PM

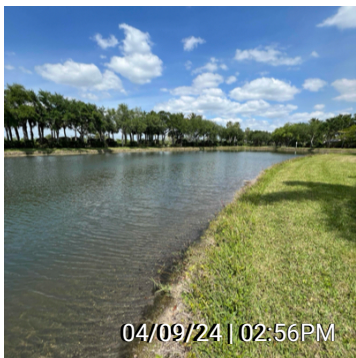
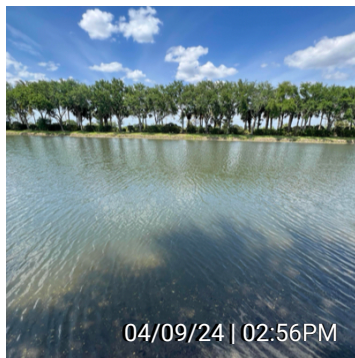
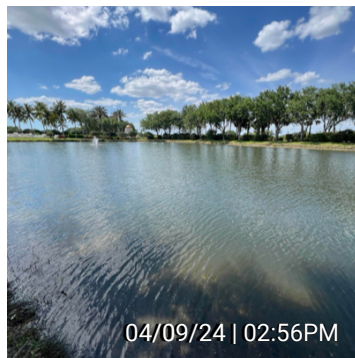
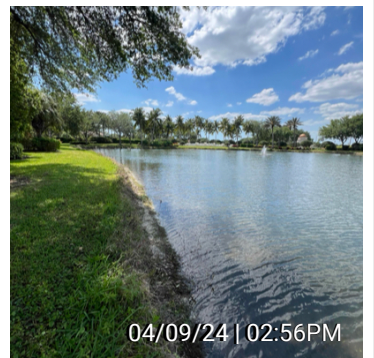
28. Lake 54 is in good condition. Did not see aerator functioning in lake. Took pictures from the South side of lake.

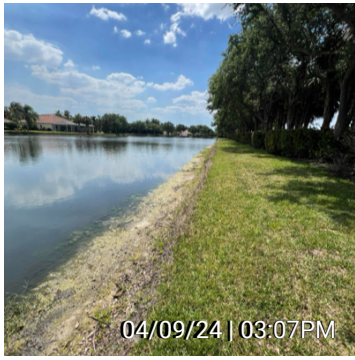
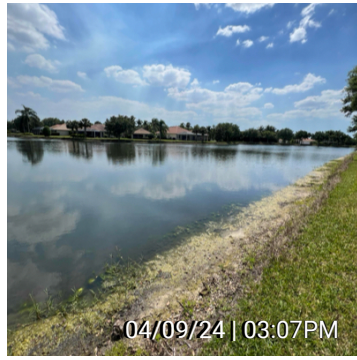
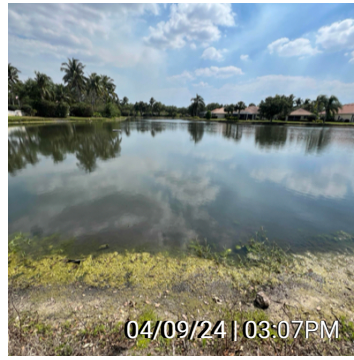
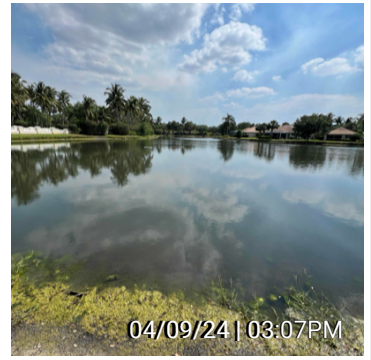
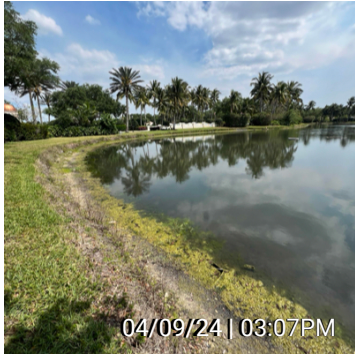
29. Lake 53 is in good condition. Took pictures from the NE corner of lake. NOTE: pond fountain not on for this lake, but is on for lake 54. Did not see aerator functioning in lake.

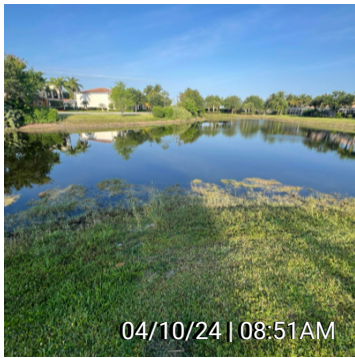
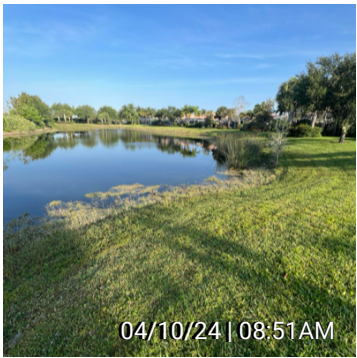
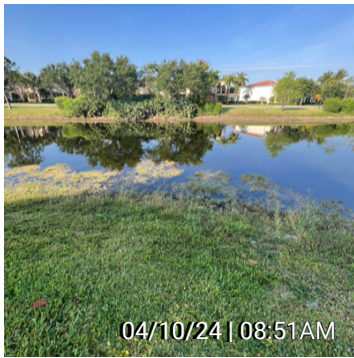
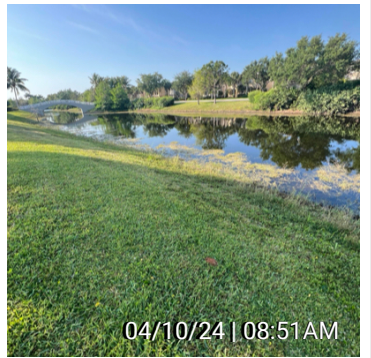
30. Lake 25 is in good condition. Took pictures from the South side of lake. Noticed 1 aerator functioning in lake.

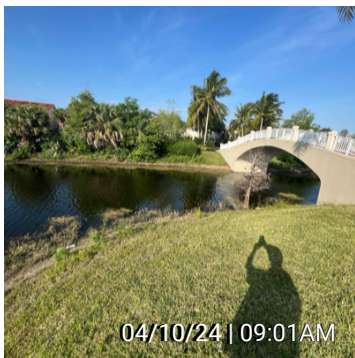
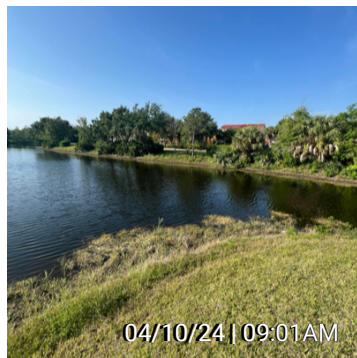
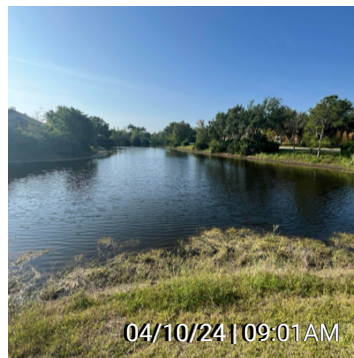
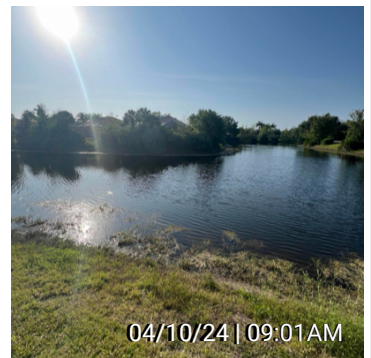
31. Lake 24 is in good condition. Took pictures from the SW side of lake. Noticed 1 aerator functioning in lake.

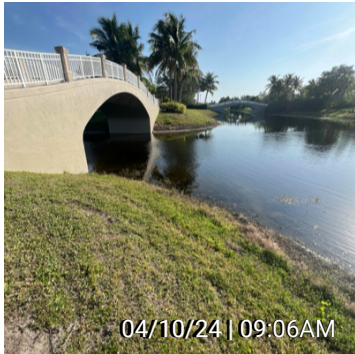
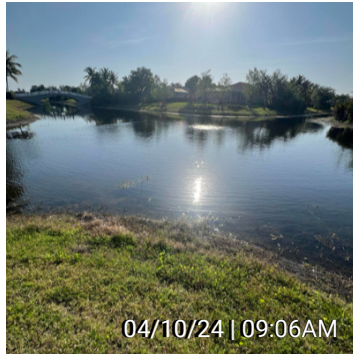
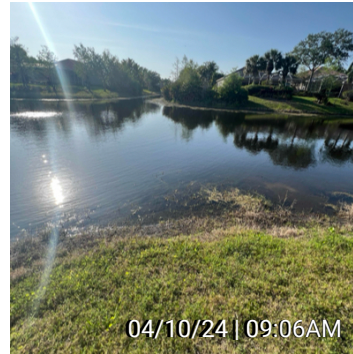
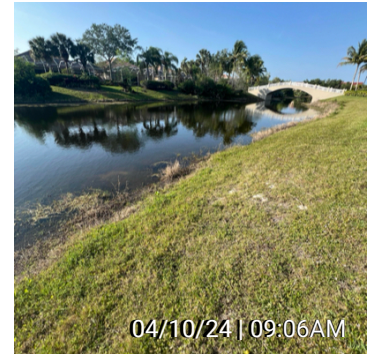
32. Lake 22 is in good condition. Took pictures from the North side of lake. Noticed 1 aerator functioning in lake.

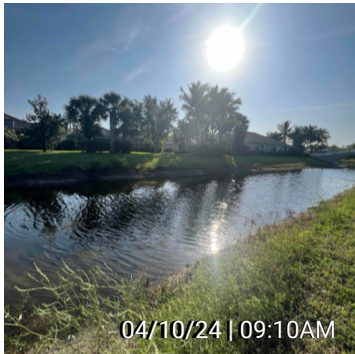
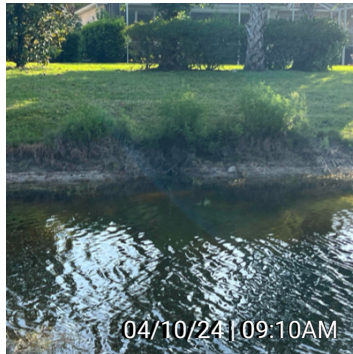
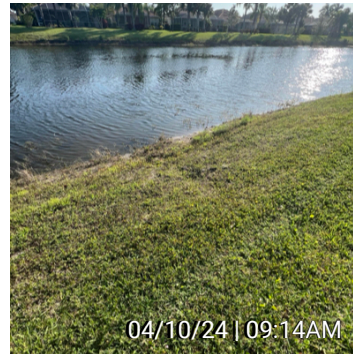
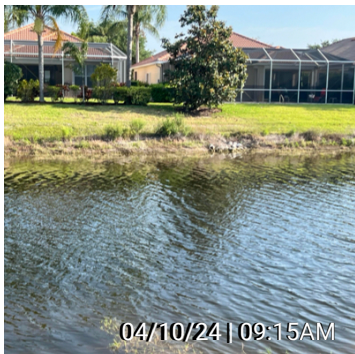
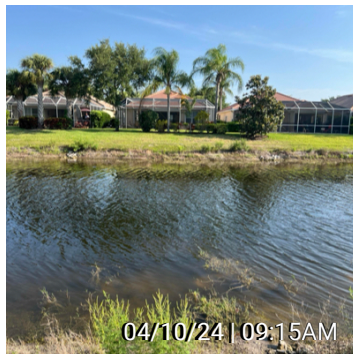
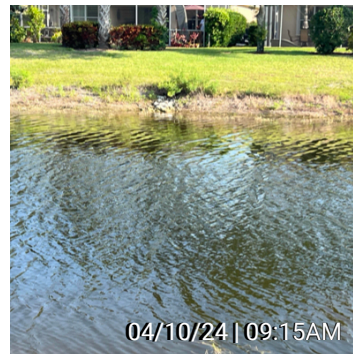
33. Lake 21 washout formed on the NE side of lake located behind the 19th lot on Danios Drive road. Washouts forming on the SW side of lake located behind the 5th and 2nd lot on Cuberra Lane road. Washout formed on the NE side of lake located behind the 12th lot on Danios Drive road and looks like homeowners added rock to prevent further damage. Noticed 1 aerator functioning in lake.

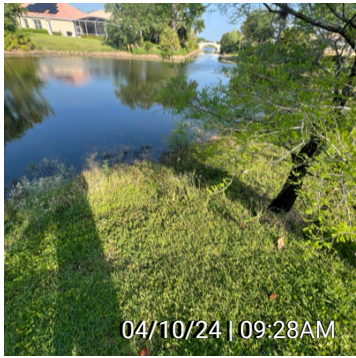
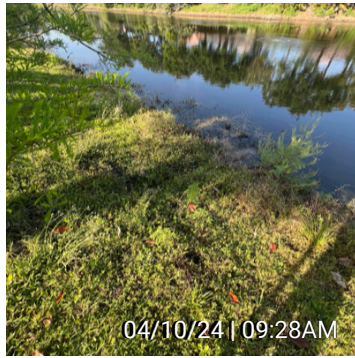
34. Lake 23 has 1 washout forming on the East side of lake located behind the 9th lot on Yellow Fin Trail road. Noticed 1 aerator functioning in lake.

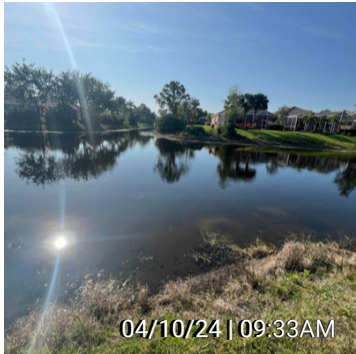
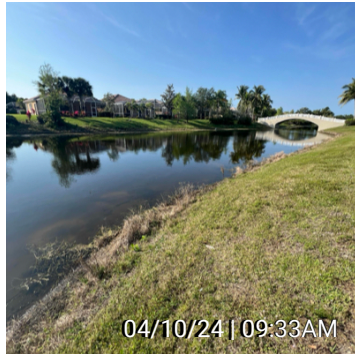
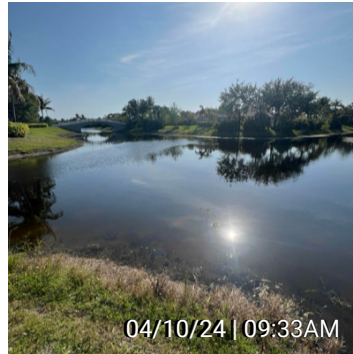
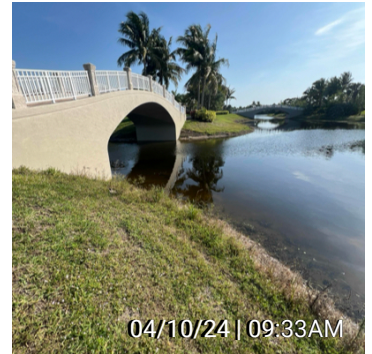
35. Lake 18 is in good condition. Took pictures from the NW side of lake. Did not see aerator functioning in lake.

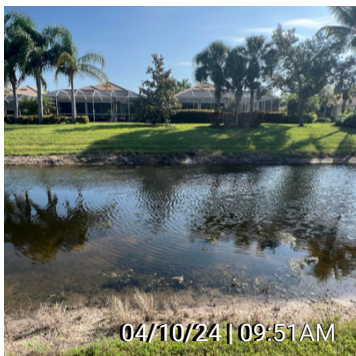
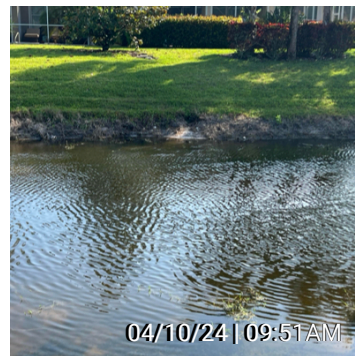
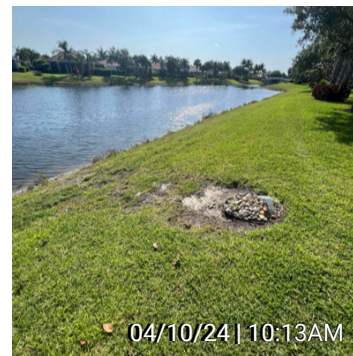
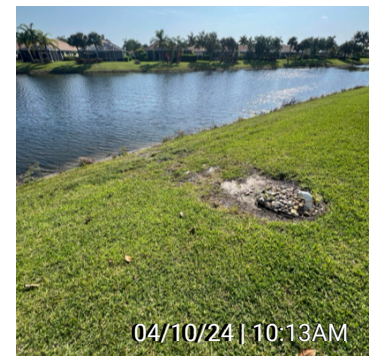
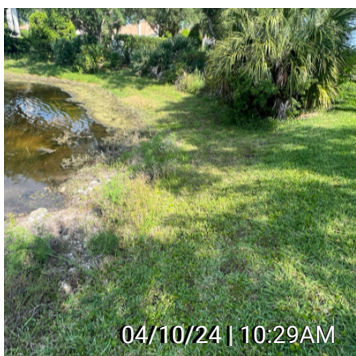
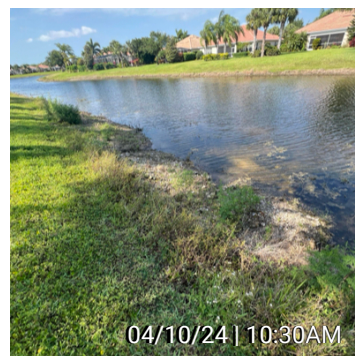
36. Lake 19 washout forming on the East side of lake located behind the 20th lot on Guinivere Way road. Washout forming on the South side of lake from pool drain located behind the 14th lot on Danios Drive road. Washouts formed on the NE side of lake located behind the 2nd lot on Guinivere Way road, looks like homeowner added some rock to help stabilize. Washout forming on the East side of lake located behind the 14th lot on Guinivere Way road. Did not see aerator functioning in lake.

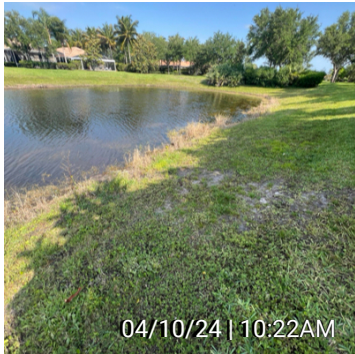
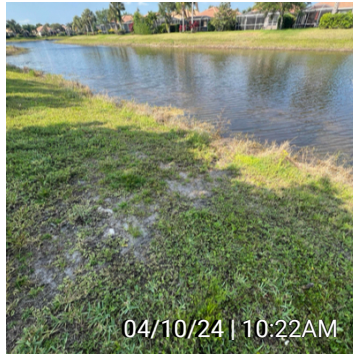
- 37.** Lake 20 has washout forming in the East side of lake located behind the 2nd lot on Finch Terrace road. Noticed 1 aerator functioning in lake.

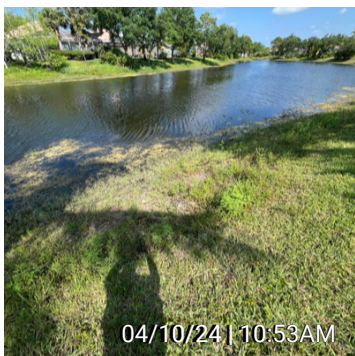
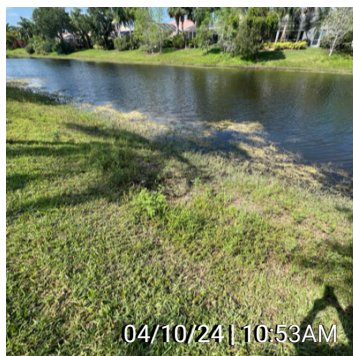
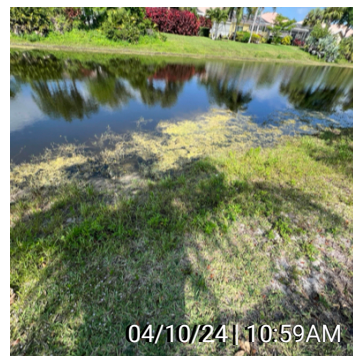
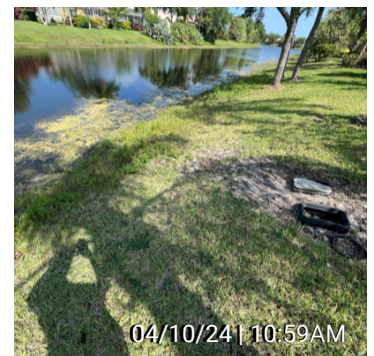
- 38.** Lake 17 has washouts on the East side of lake that have stabilized with sod located behind the 7th and 1st lot on Xenon Way road. Did not see aerator functioning in lake.

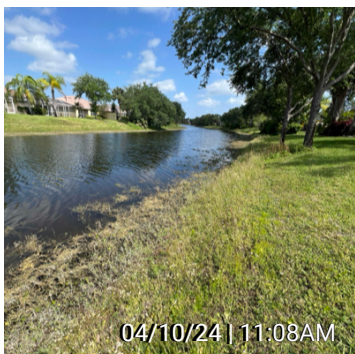
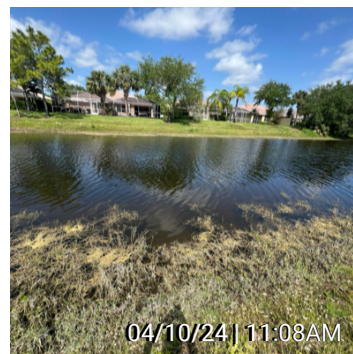
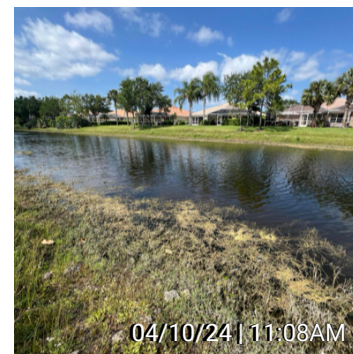
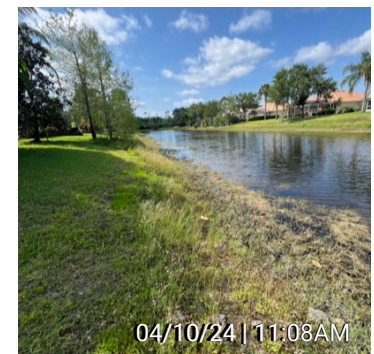
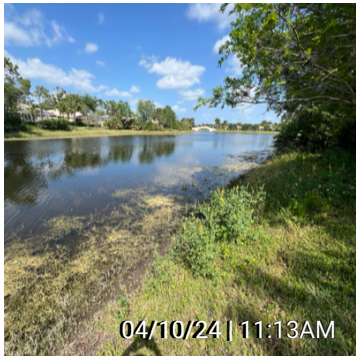
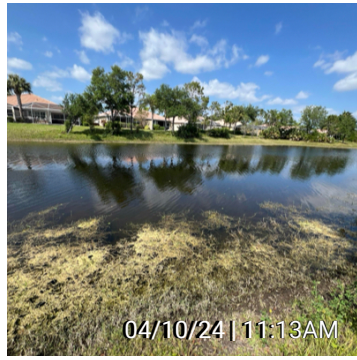
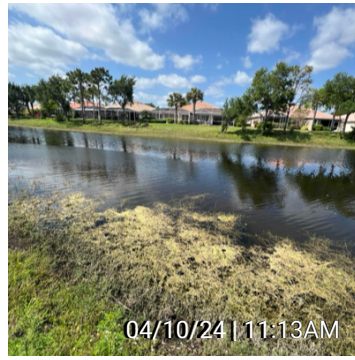
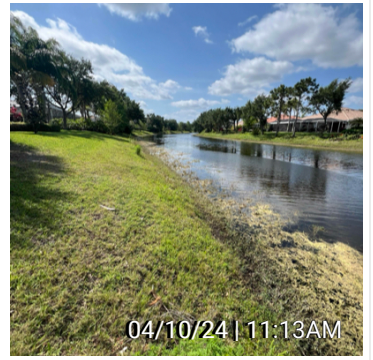
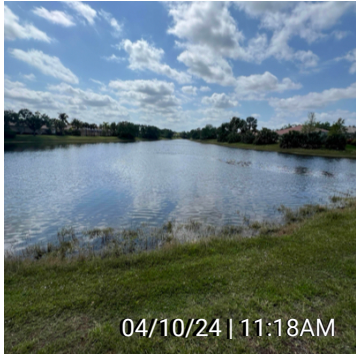
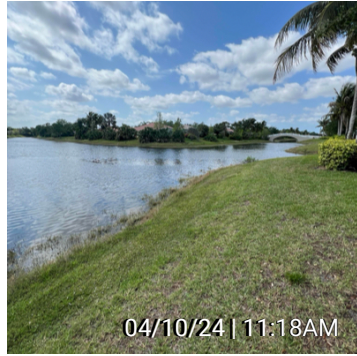
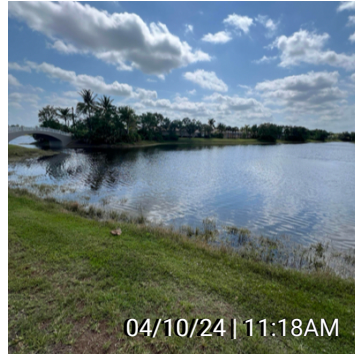
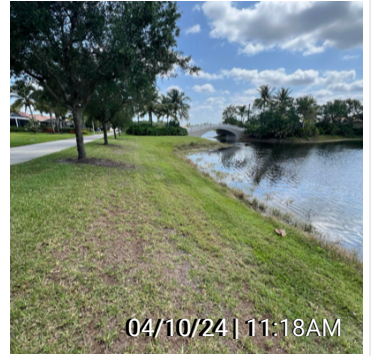
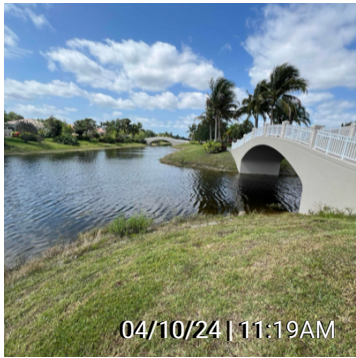
- 39.** Lake 15 is in good condition. Took 8 pictures along the East side of lake starting from the South end of lake and took 5 pictures on the North end of lake. Noticed 1 aerator functioning in lake.
