Village Walk Lake Bank Assessment

28041 Eagle Ray Ct Bonita Springs, FL 34135

Date Tue 04/09/2024

Job # 050018.00.11

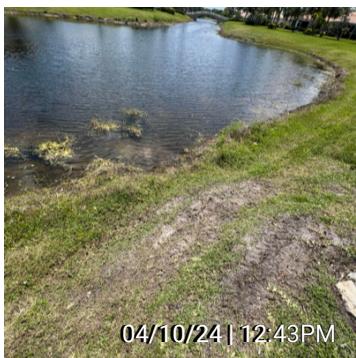
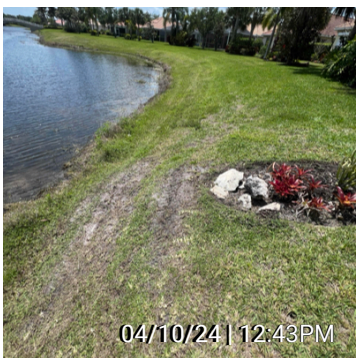
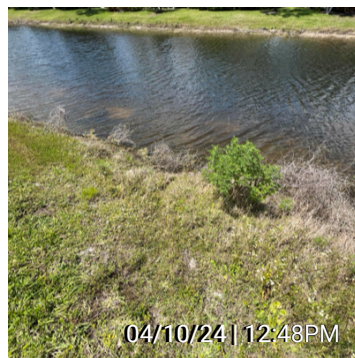
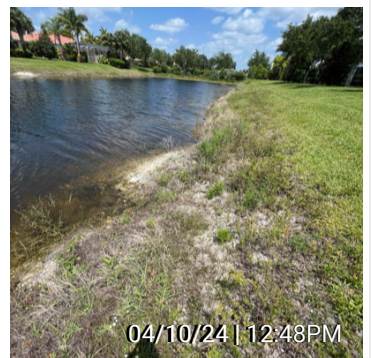
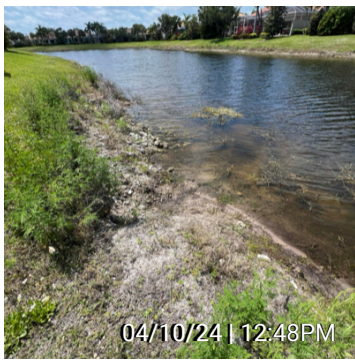
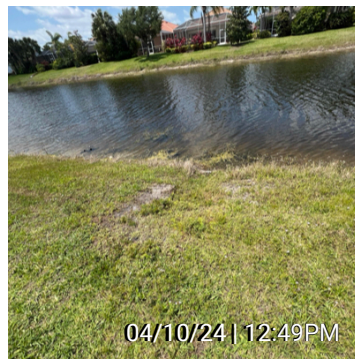
40. Lake 16 has washout forming on the West side of lake located behind the 9th lot on Guinivere Way road. Washouts located on the East side of lake located behind the 6th-9th lots on Hammerhead Lane road, looks like homeowners added rock to stabilize area. Noticed 1 aerator function in lake.
Dalton Lehnhard | 04/10/24 | 12:58PM

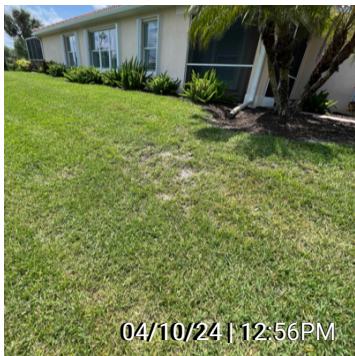
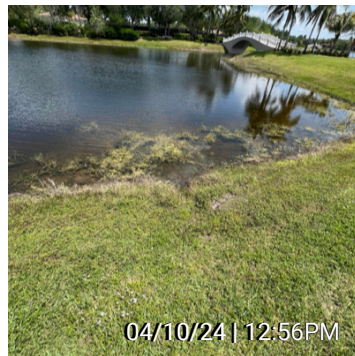
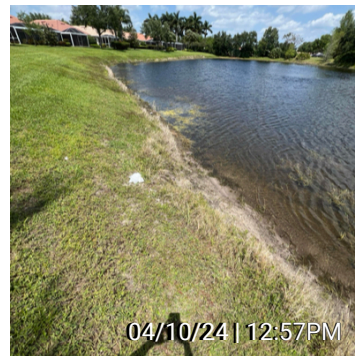
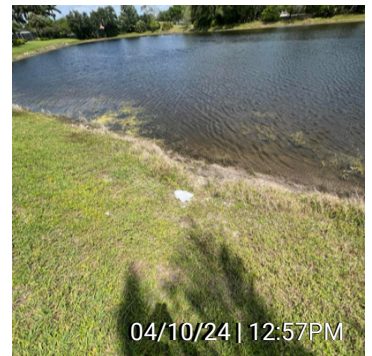
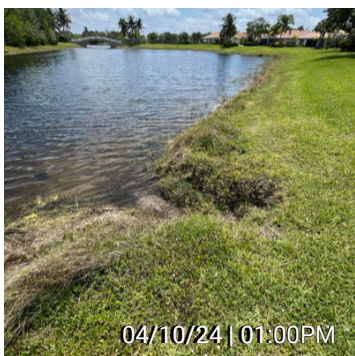
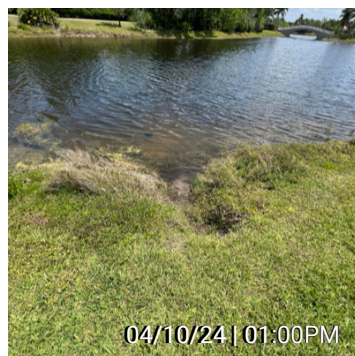
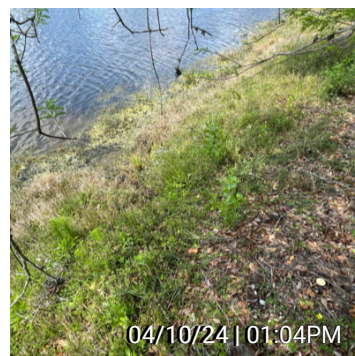
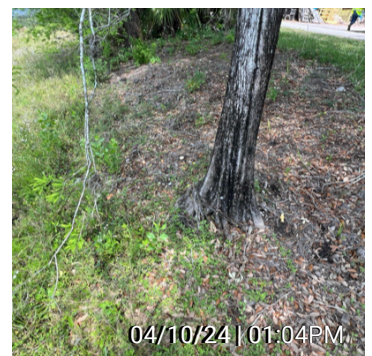
- 41.** Lake 01 washout forming on the South side of lake from roof gutter located on the side of lot at the end of street on Hammerhead Lane road. Washouts formed on the South side of lake located behind the 11th and 2nd lot on Hammerhead Lane road. Washout formed on the NE side of lake located across from the maintenance shop driveway. Noticed 1 aerator functioning in lake.
Dalton Lehnhard | 04/11/24 | 01:10PM

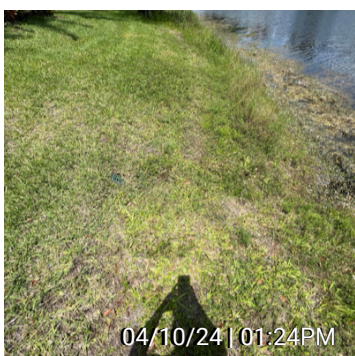
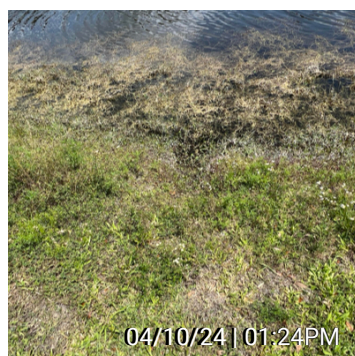
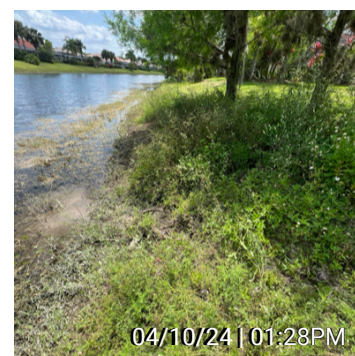
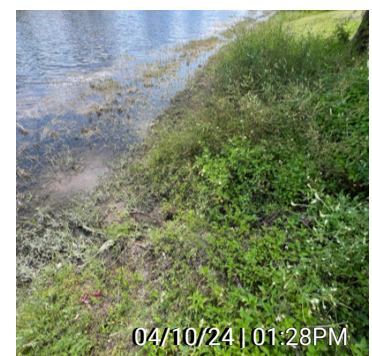
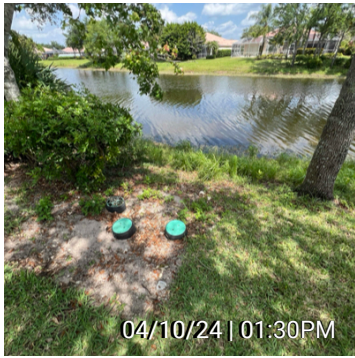
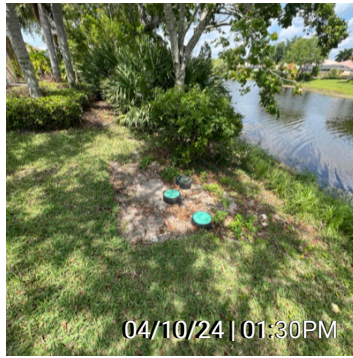
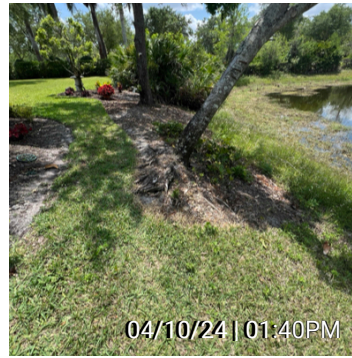
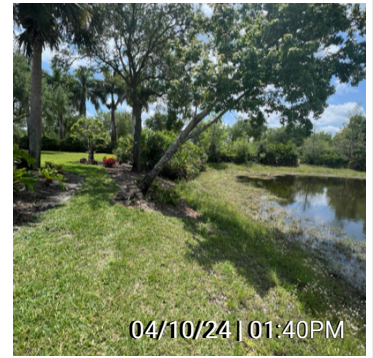
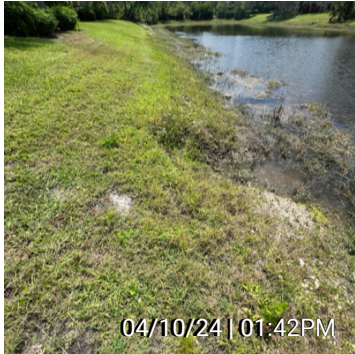
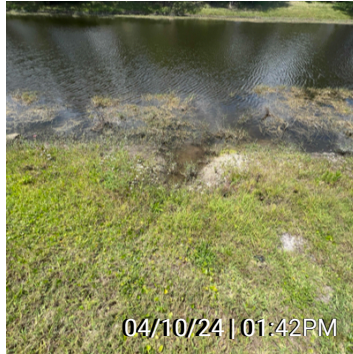
- 42.** Lake 14 has washout forming due to drain in lake bank on the West side of lake located behind the 15th lot on Wahoo Drive road. Washout forming located behind the 20th lot on Wahoo Drive road. Unstable area at top of lake bank located behind the 23rd lot on Wahoo Drive road, should stabilize with sod to prevent future washout. Tree leaning On the SE side of lake located behind the 2nd lot on Vermillion Lane road. Washout formed possibly due to drain pipe located behind the 3rd lot on Vermillion Lane road. Noticed 1 aerator functioning in lake.
Dalton Lehnhard | 04/11/24 | 01:12PM

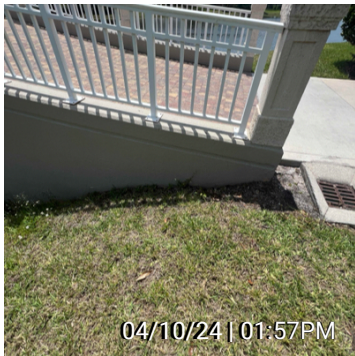
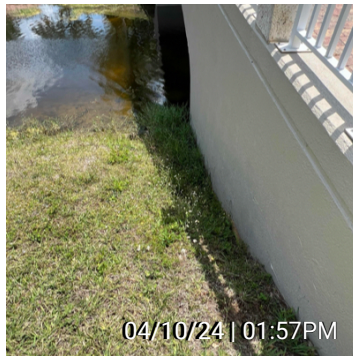
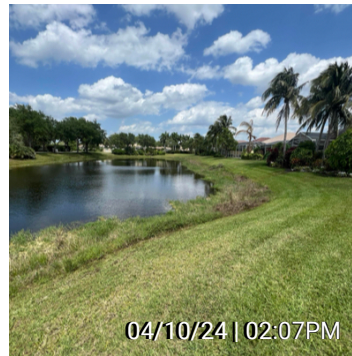
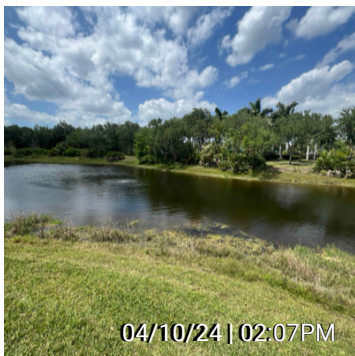
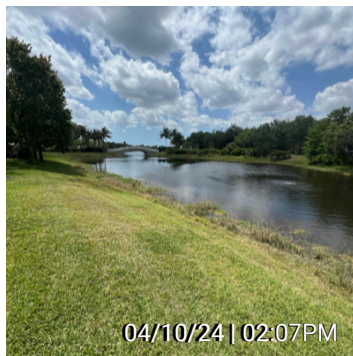
43. Lake 03 washout located by bridge that is between lakes 2 and 3 rest of lake was in good condition. Took pictures from the SW side of lake. Noticed 1 aerator function in lake.

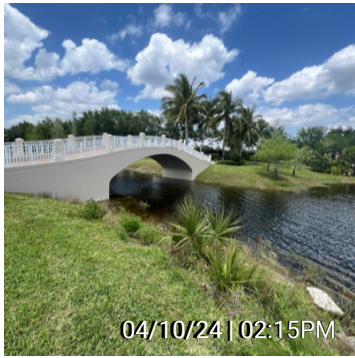
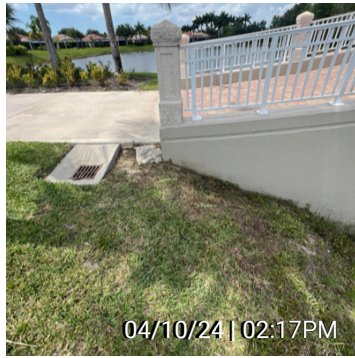
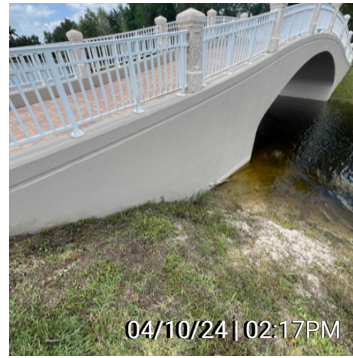
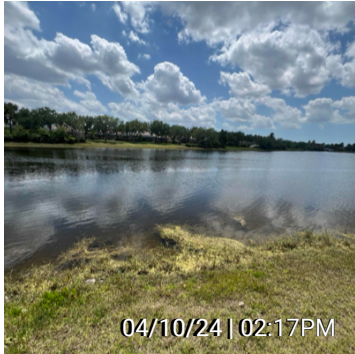
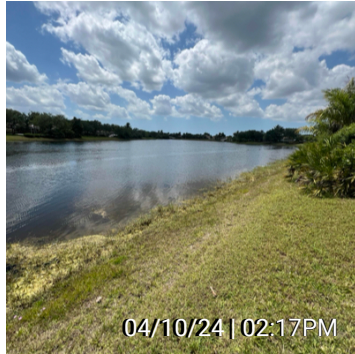
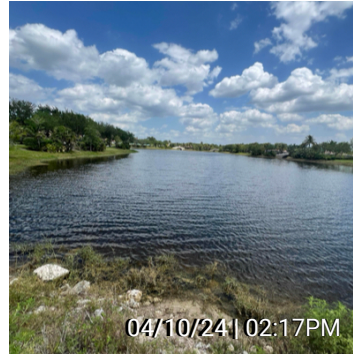
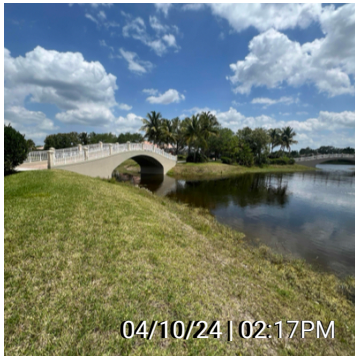
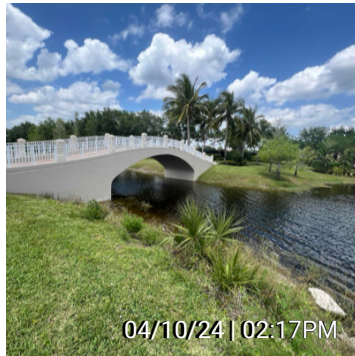
44. Lake 02 washout located by bridge that is between lakes 2 and 1, rest of lake is in good condition. Took 4 pictures from the NE corner of lake next to lake 3 and took 4 pictures on the NW corner of lake. Noticed 1 aerator function in lake. Noticed 1 aerator function in lake.

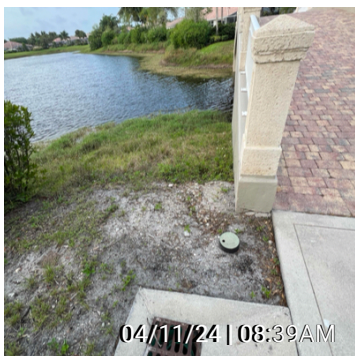
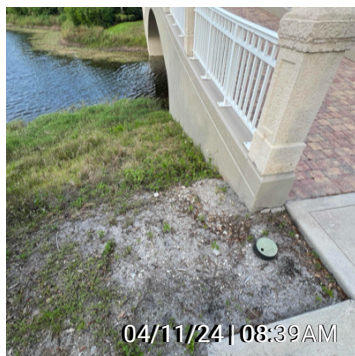
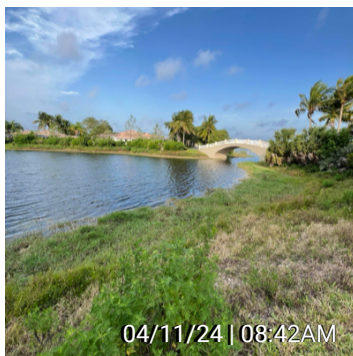
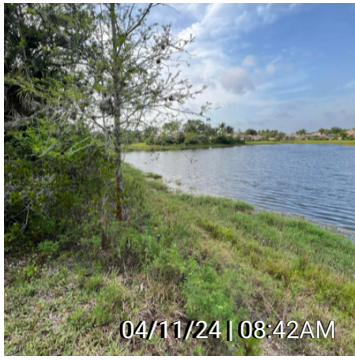
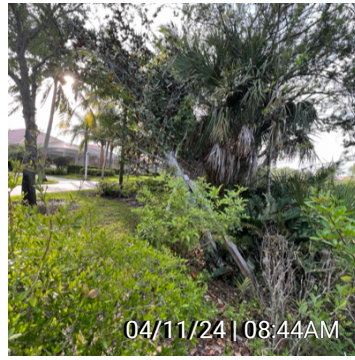
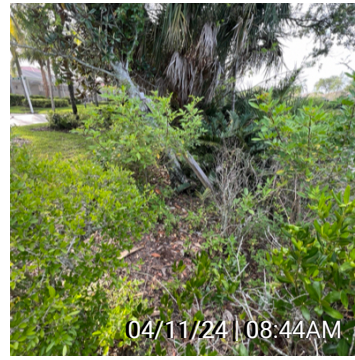
45. Lake 05 washout forming on the North side of lake located by bridge that is between lakes 05 and 02. Rest of lake is in good condition. Took pictures from the NE side of lake. Did not notice aerator functioning in lake. NOTE: tree falling at top of bank on NE side of lake located behind lots at the end of Moray Drive.
Dalton Lehnhard | 04/11/24 | 09:03AM

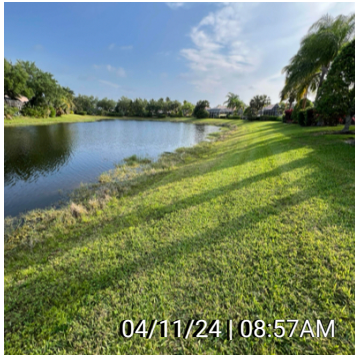
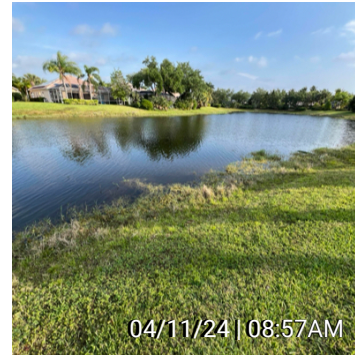
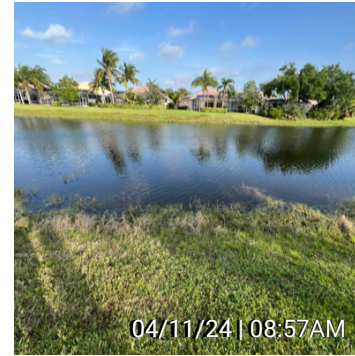
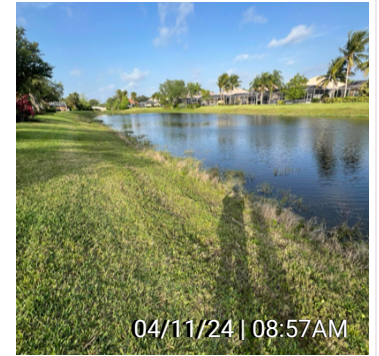
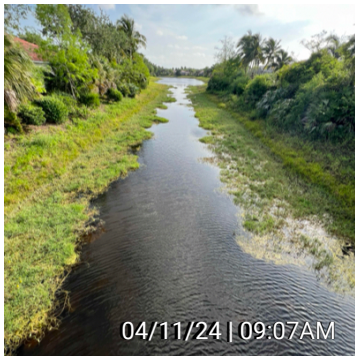
46. Lake 04 is in good condition. Took pictures from the SE side of lake. Noticed 1 aerator function in the lake. Took 1 picture from bridge.

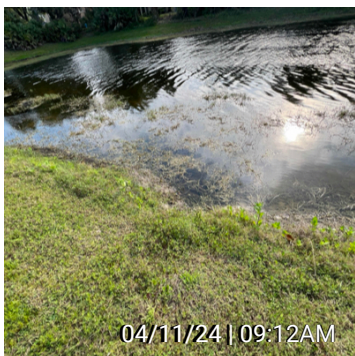
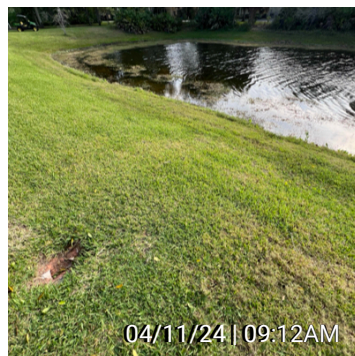
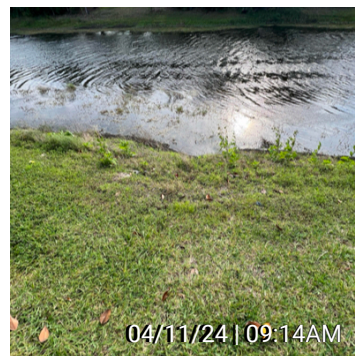
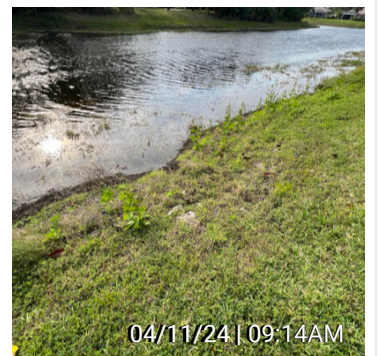
47. Lake 06 has washouts forming on NW side of lake located behind the 2nd and 3rd lot on Nautica Lane road. The rest of lake is in good condition. Did not see aerator functioning in lake.

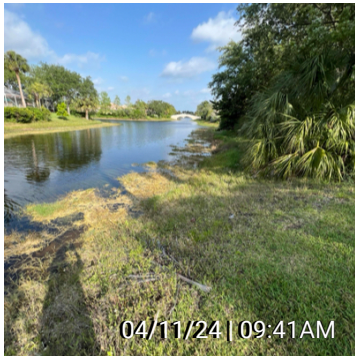
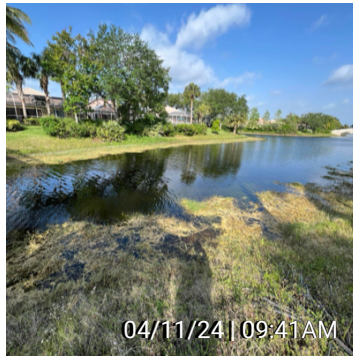
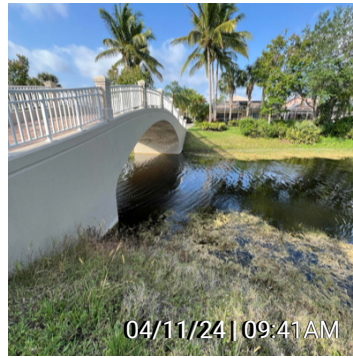
48. Lake 08 is in good condition. Took pictures from the East side of lake by bridge that is between lakes 8 and 11. Did not see aerator functioning in lake.

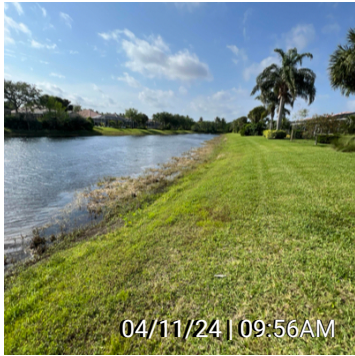
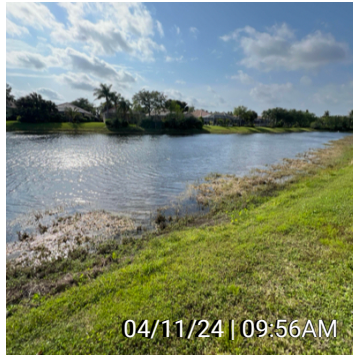
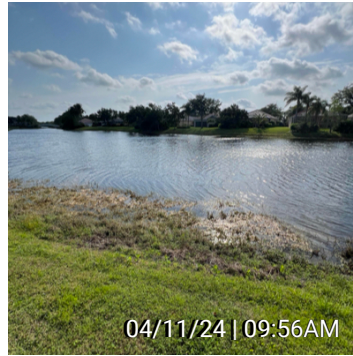
49. Lake 07 is in good condition. Took pictures from the North side of lake. Did not see aerator functioning in lake.

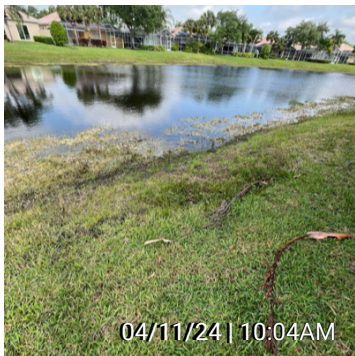
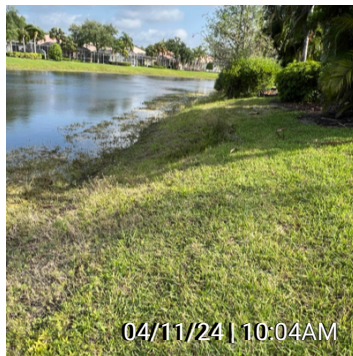
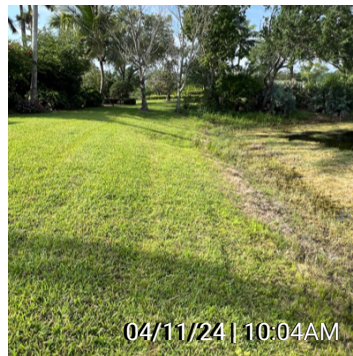
50. Lake 10 washouts formed on the SE side of lake that have stabilized with sod located behind the 2nd and 3rd lots on Scrub Jay Lane road. Noticed 1 aerator functioning in lake.

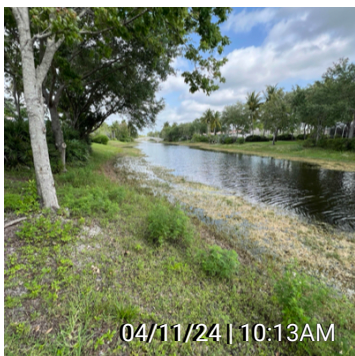
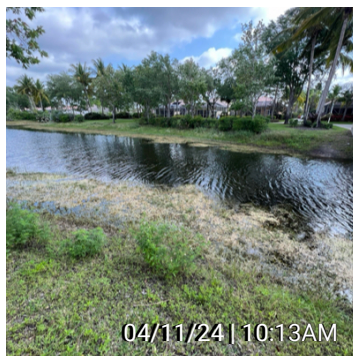
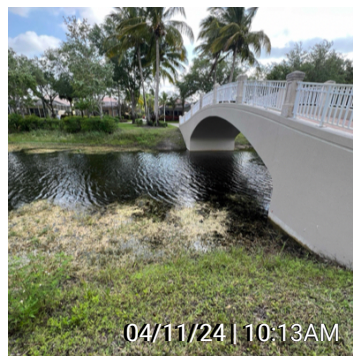
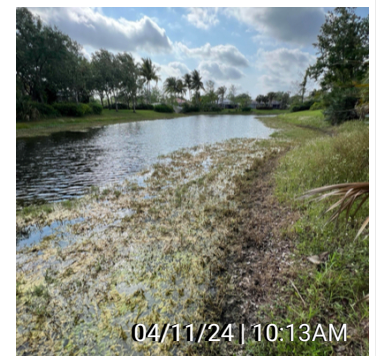
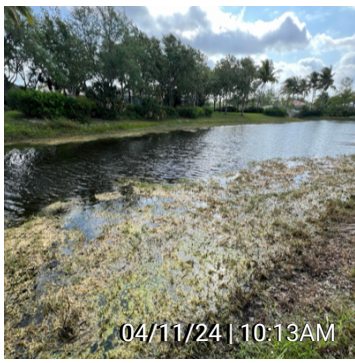
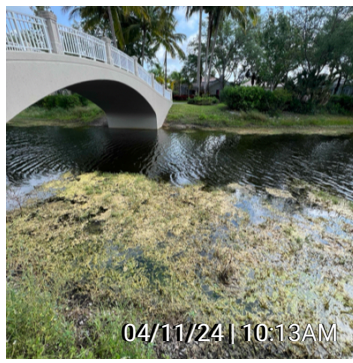
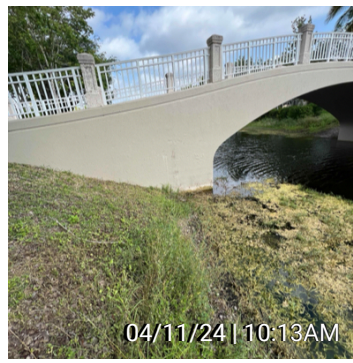
51. Lake 11 is in good condition. Took pictures on the West side of lake on the South and North side of bridge. Did not see aerator functioning in lake.

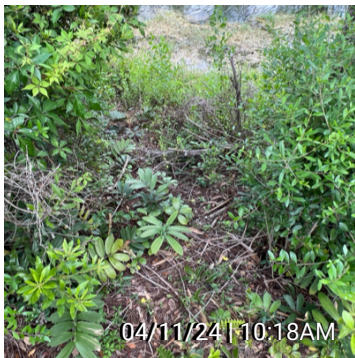
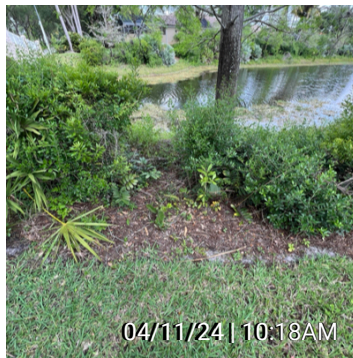
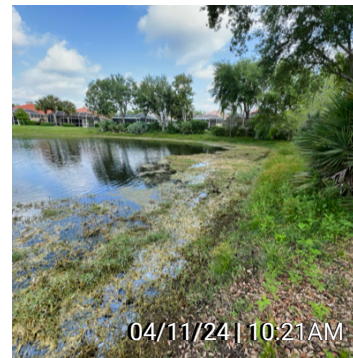
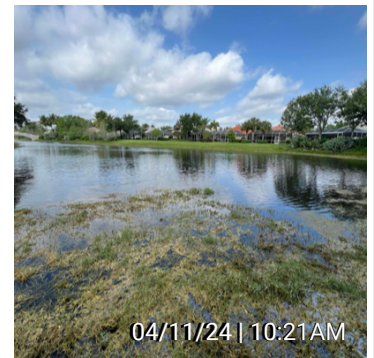
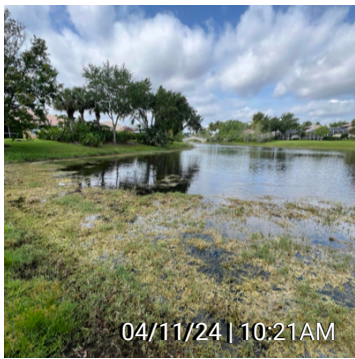
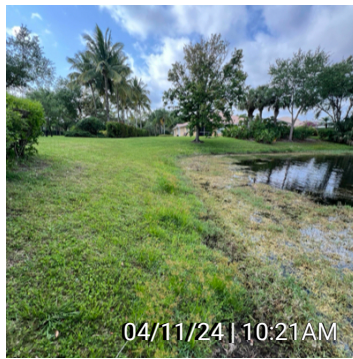
- 52.** Lake 12 washout formed in landscape bed/ area on the South side of lake located on the East side bridge that is between lakes 12 and 13. The rest of lake is in good condition. Took 4 pictures from the East end of lake. Noticed 1 aerator functioning in lake.

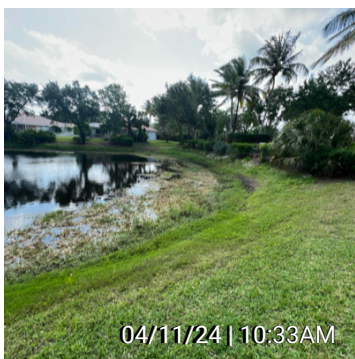
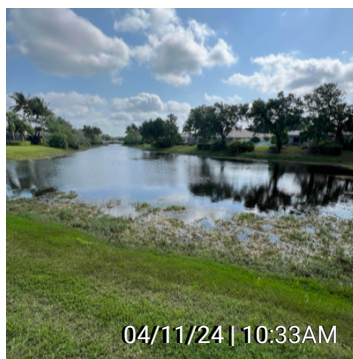
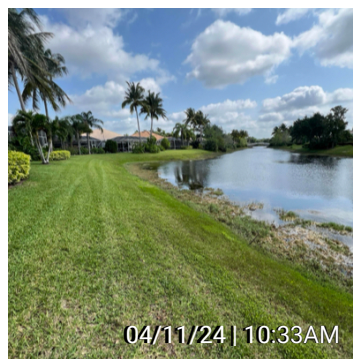
- 53.** Lake 13 is in good condition. Took pictures from the West end of lake. Noticed 1 aerator functioning in lake.

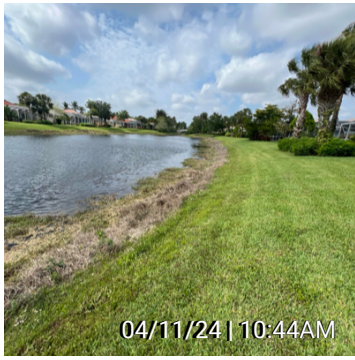
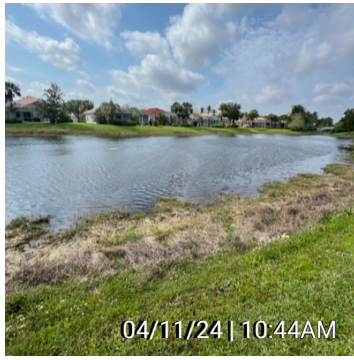
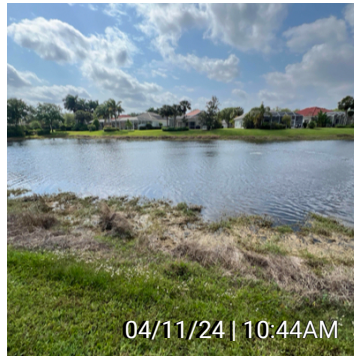
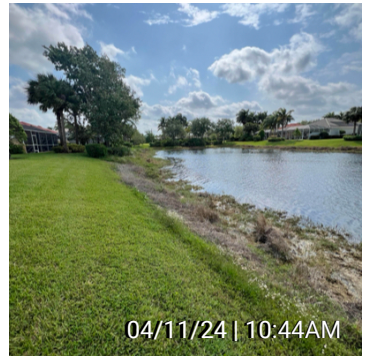
- 54.** Lake 09 is in good condition. Took pictures from the North side of lake. Noticed 1 aerator functioning in the lake.
