# Village Walk Lake Bank Assessment

28041 Eagle Ray Ct Bonita Springs, FL 34135

Date Wed 06/09/2021

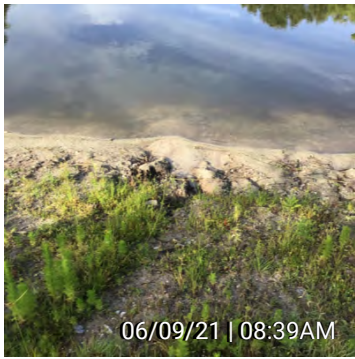
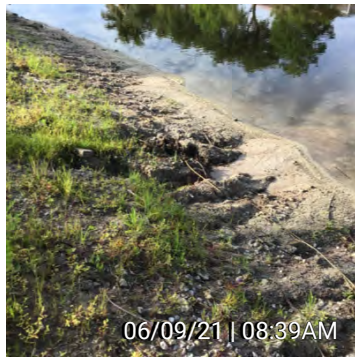
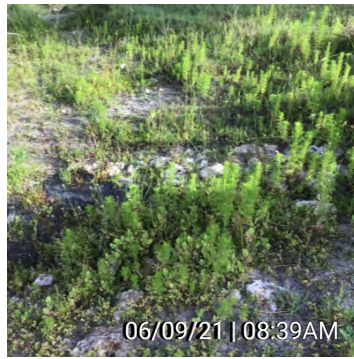
**2. Figure 2 - Minor Rilling and washout previously stabilized with riprap that has been washed out**

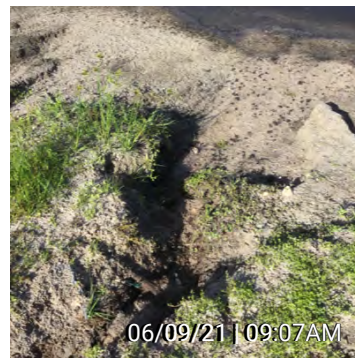
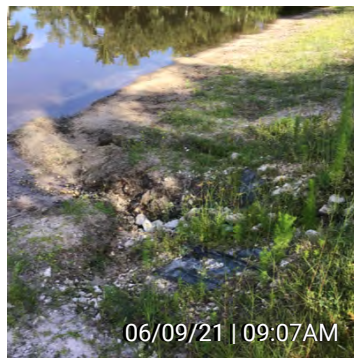
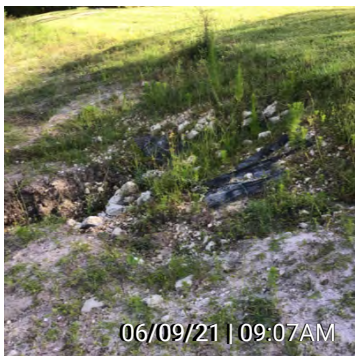
**3. Figure 3- Washout**

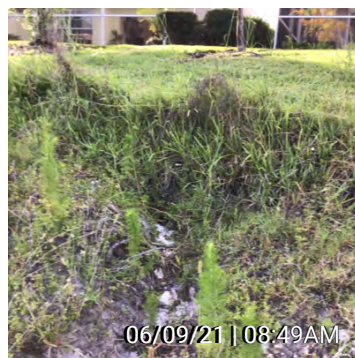
#### 4. Figure 4 - Multiple Washouts due to Rilling and Gullies

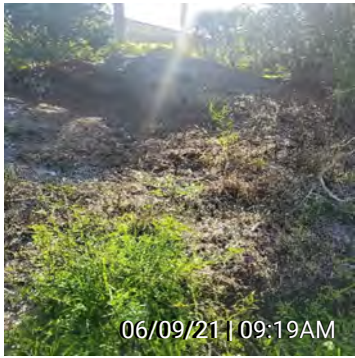
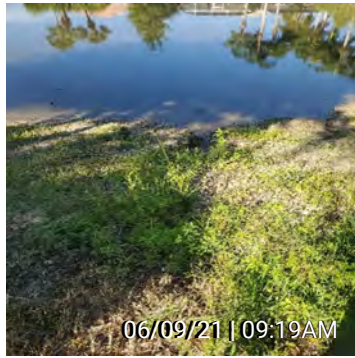
#### 8. Figure 8 - Washout

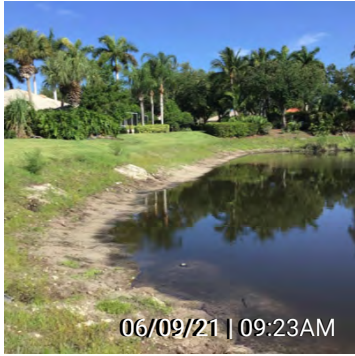
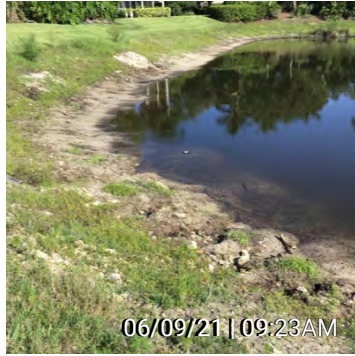
**9. Figure 9 - Rilling at lake bank, downspout pipe to be extended into lake to mitigate rilling around pipe**

2. 1. Several washouts were caused by the residents' drain pipes not reaching all the way down to the slope of the lake's normal pool elevation. If the drain pipe get extended this will prevent further washouts in those areas.
2. During the wet season, the grass should be kept high, adjacent to the water and approximately one to two mowers' wide. This will decrease the velocity of the runoff and help prevent erosion near the lake bank.
3. There are humps on the lake bank that are either keeping some runoff stagnant or increasing the velocity around the slope of the hump causing erosion. These areas should be sloped to a minimum 4:1.
4. There are areas specified on the Lake Bank Exhibit that have slight erosion and soft dirt. Permanent seeding will establish perennial vegetative cover that will reduce the erosion and decrease the sediment yield from the disturbed areas.

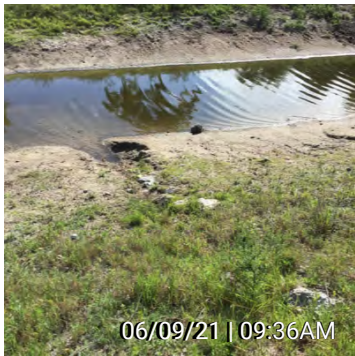
**10. Figure 10 - Rilling from downspout drain (Recurring)**

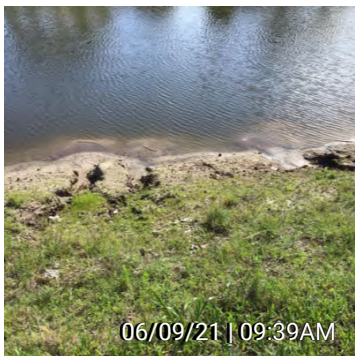
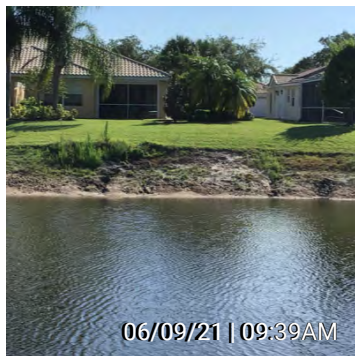
**11. Figure 11 - Washouts**

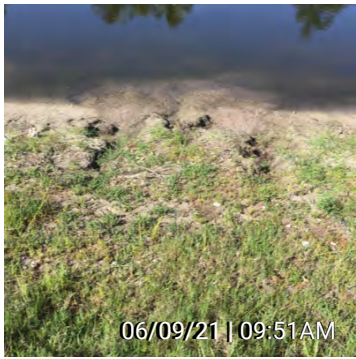
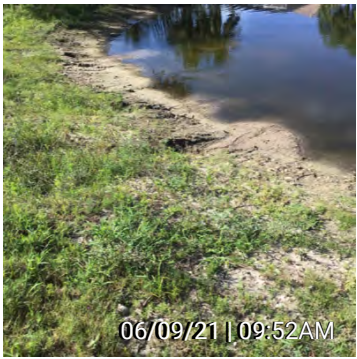
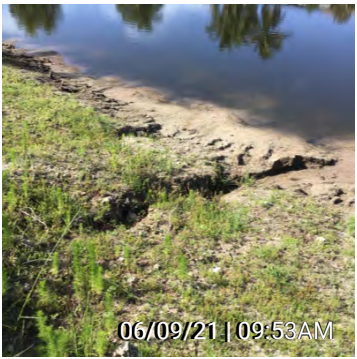
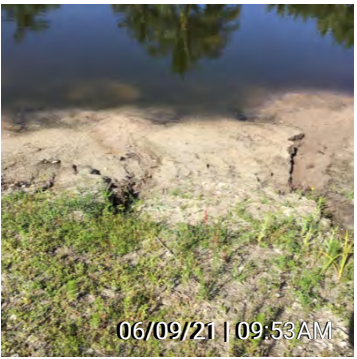
**13. Figure 13 Washout and Rilling (Recurring)**

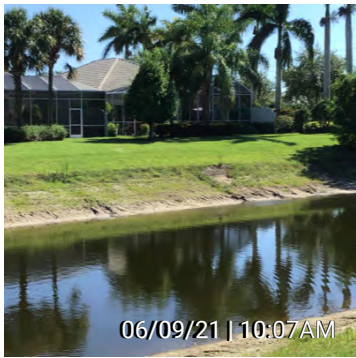
**15. Figure 15 - Minor rilling**

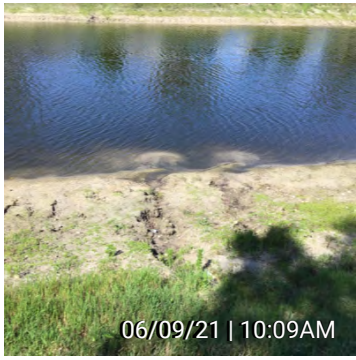
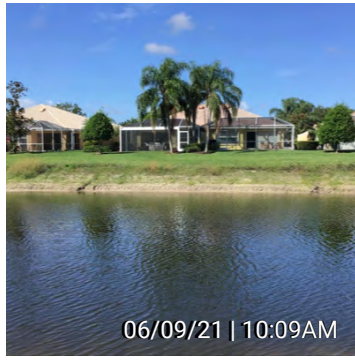
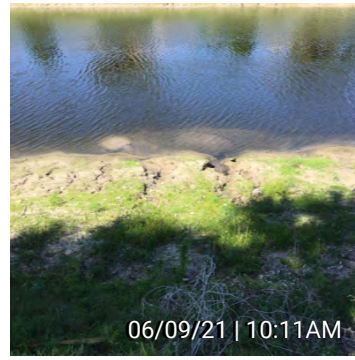
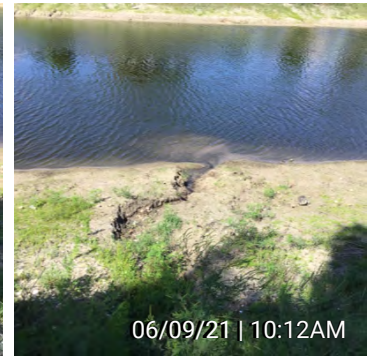
**16. Figure 16 Washouts**

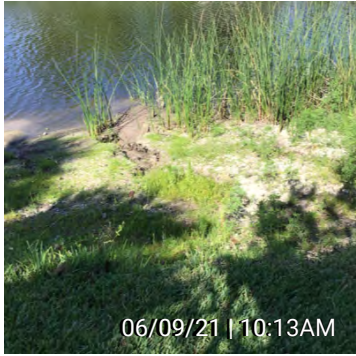
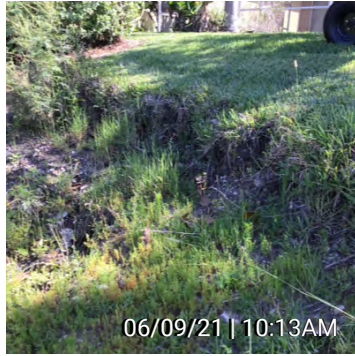
**17. Figure 17 - Drop greater than 9" with washout**

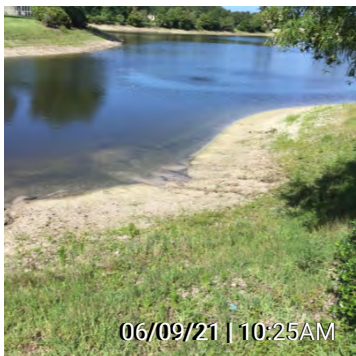
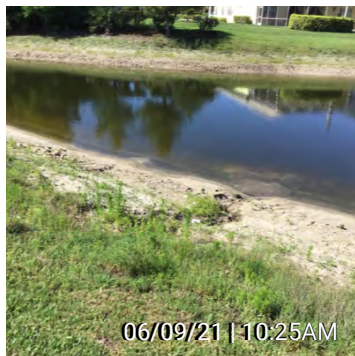
**19. Figure 19 - Washouts**

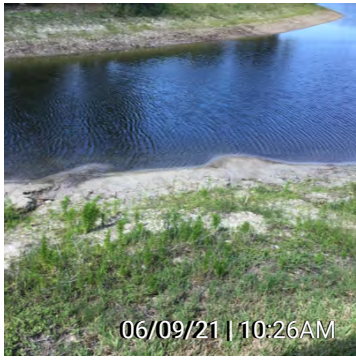
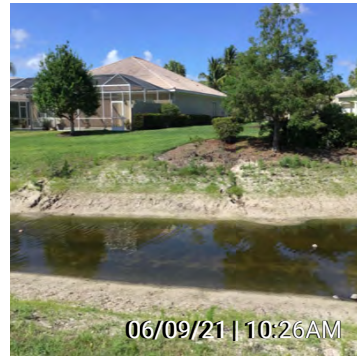
**20. Figure 20 - Rills**

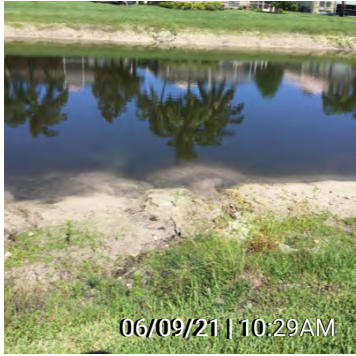
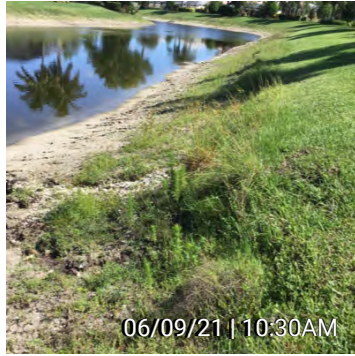
## 21. Figure 21 - Rills

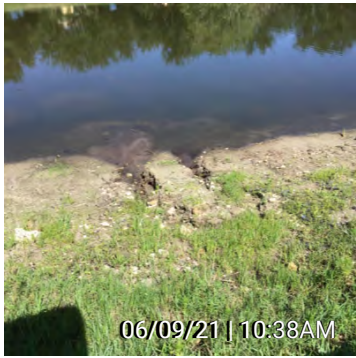
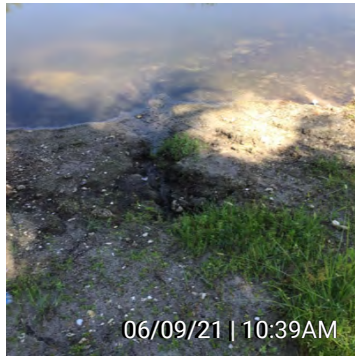
## 24. Figure 24 - Minor rilling

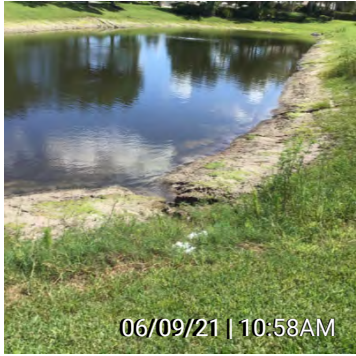
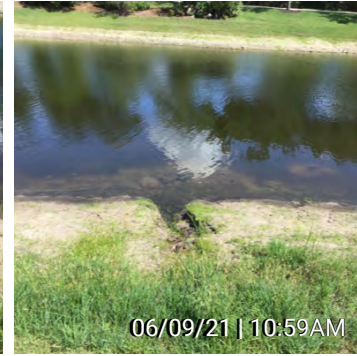
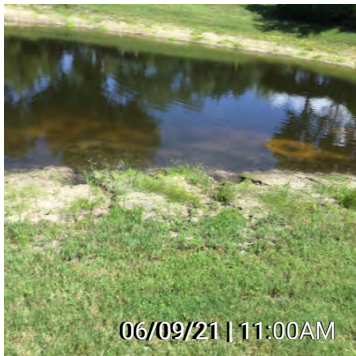
## 25. Figure 25 - Washouts and rilling

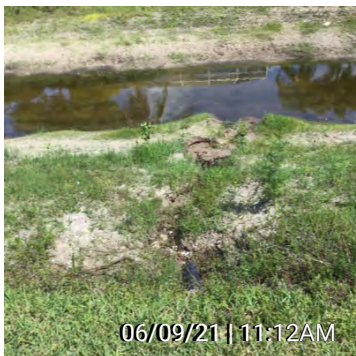
## 26. Figure 26 - Downspout eroding lake bank. Extend to low water level

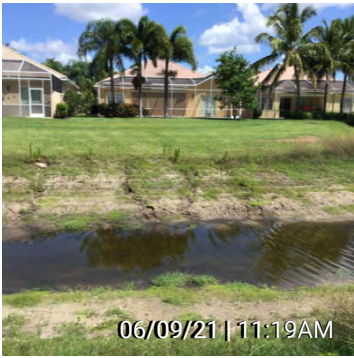
## 27. Figure 27 - Erosion at lake bank

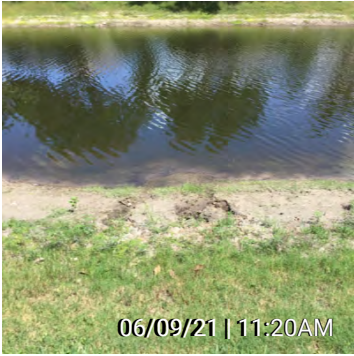
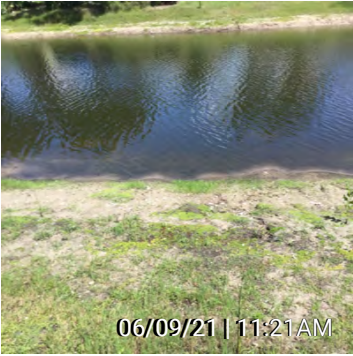
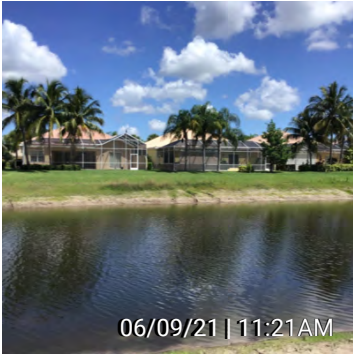
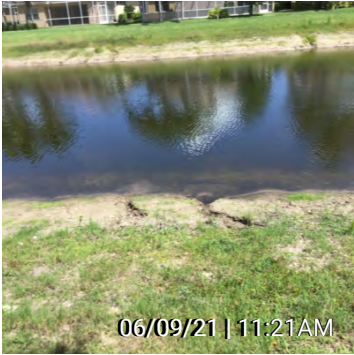
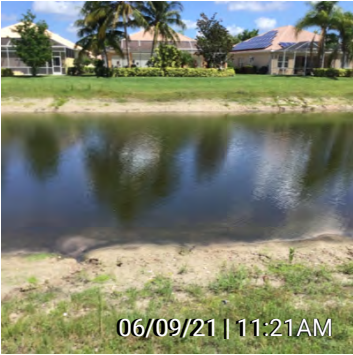
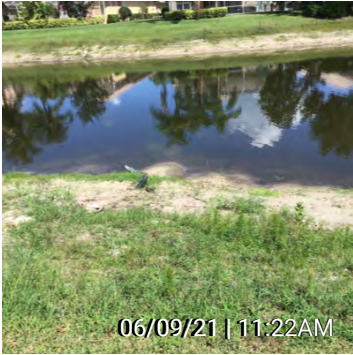
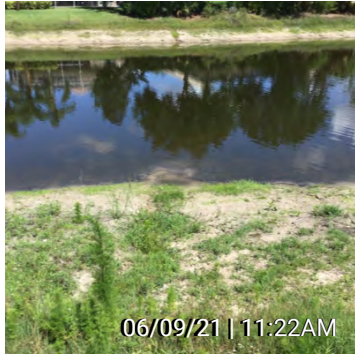
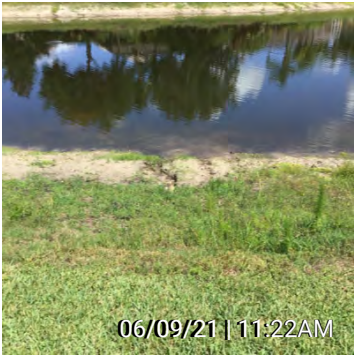
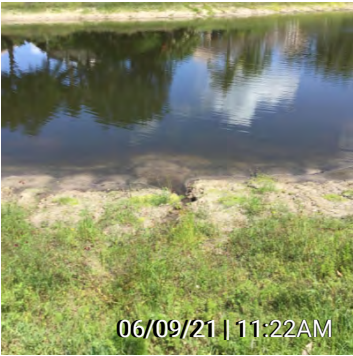
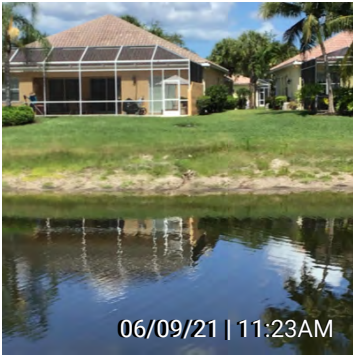
28. Figure 28 - Minor Washouts at Lake Bank

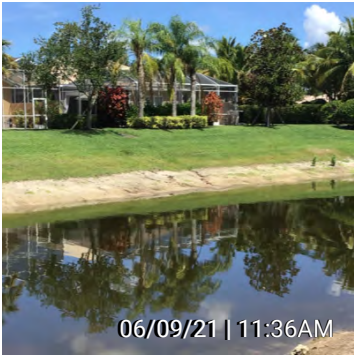
29. Figure 29 - Washout

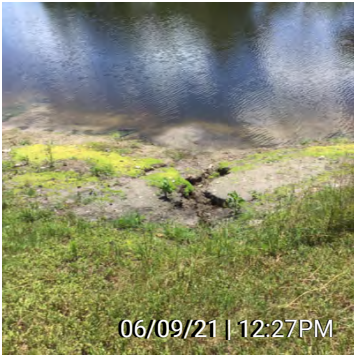
**30. Figure 30 - Washout**  
Dan DiVincenzo | 07/08/21 | 04:09PM

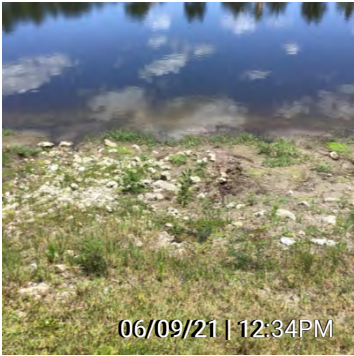
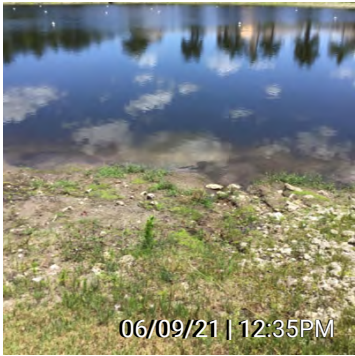
**31. Figure 31 - Washout**  
Dan DiVincenzo | 07/08/21 | 04:47PM

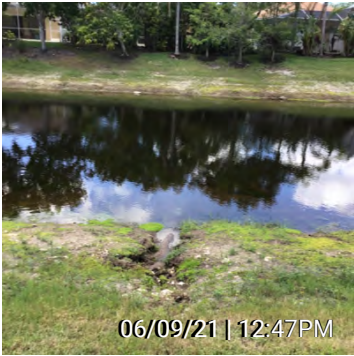
**32. Figure 32 - Washout (Recurring)**  
Dan DiVincenzo | 07/08/21 | 04:09PM

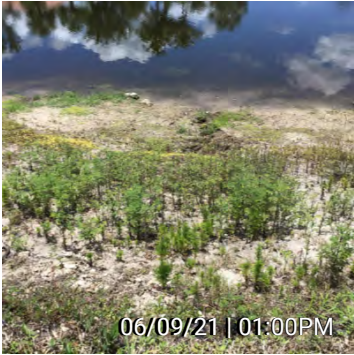
**33. Figure 33 - Washout**  
Dan DiVincenzo | 07/08/21 | 04:47PM

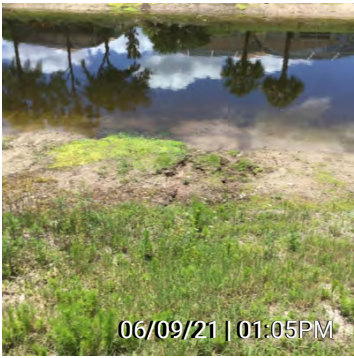
**34. Figure 34 - Washout**  
Dan DiVincenzo | 07/08/21 | 04:48PM

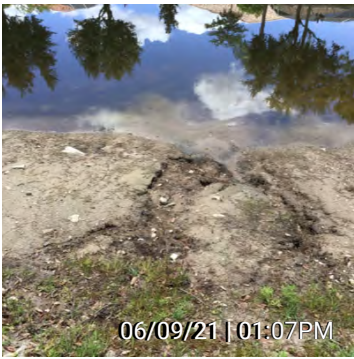
**35. Figure 35 - Washout**  
 Dan DiVincenzo | 07/08/21 | 04:10PM

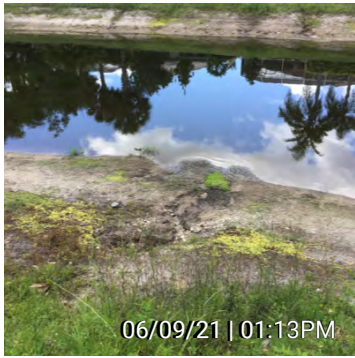
**36. Figure 36 - Washout (Recurring)**  
 Dan DiVincenzo | 07/08/21 | 04:10PM

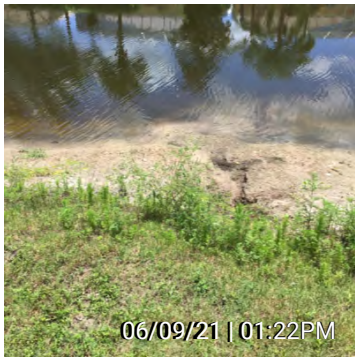
**37. Figure 37 - Washout**  
Dan DiVincenzo | 07/08/21 | 04:38PM

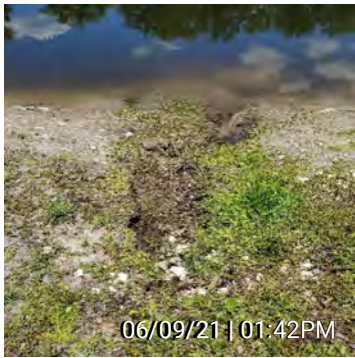
**39. Figure 39 - Washout**  
Dan DiVincenzo | 07/08/21 | 04:17PM

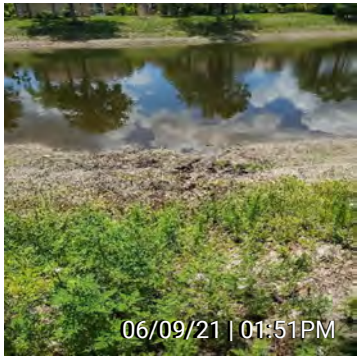
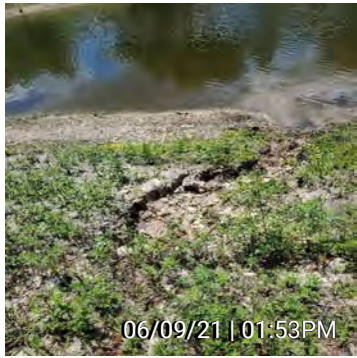
**40. Figure 40 - Erosion**  
Dan DiVincenzo | 07/08/21 | 04:17PM

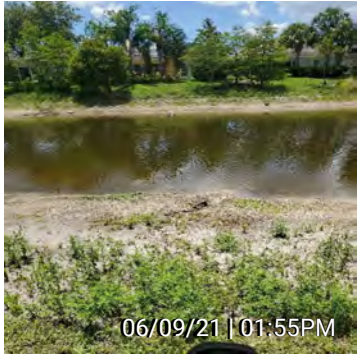
**41. Figure 41 - Washout**  
Dan DiVincenzo | 07/08/21 | 04:32PM

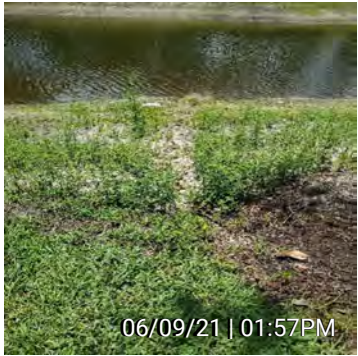
**43. Figure 43 - Washout**  
Dan DiVincenzo | 07/08/21 | 04:30PM

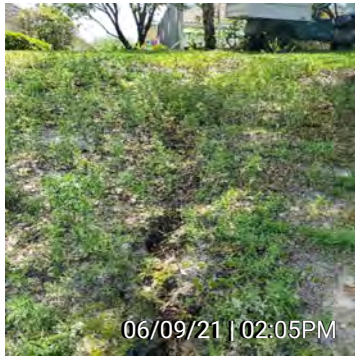
**44. Figure 44 - Deep washout**  
Dan DiVincenzo | 07/08/21 | 04:18PM

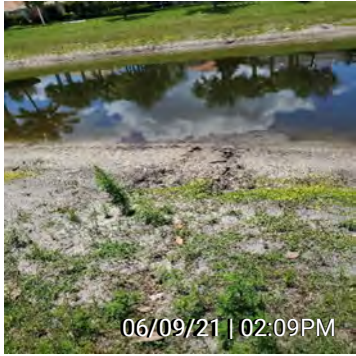
**45. Figure 45 - Erosion**

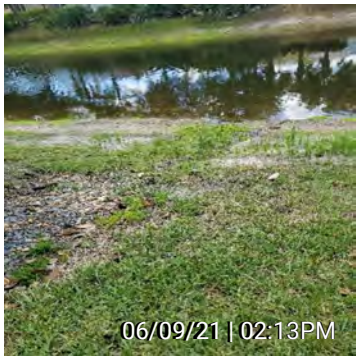
**46. Figure 46 - Pool overflow causing washout**

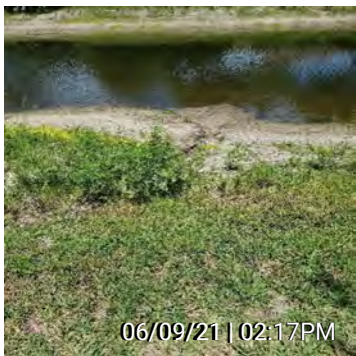
**47. Figure 47 - Washout**

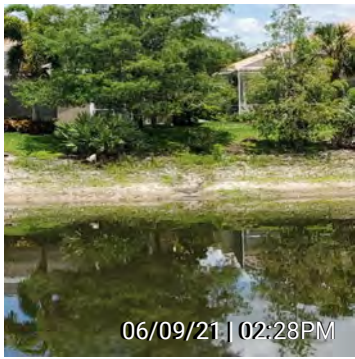
**49. Figure 49 - Washout**  
Dan DiVincenzo | 07/08/21 | 04:19PM

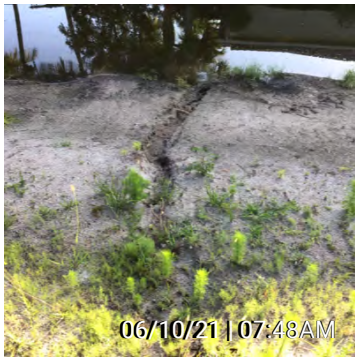
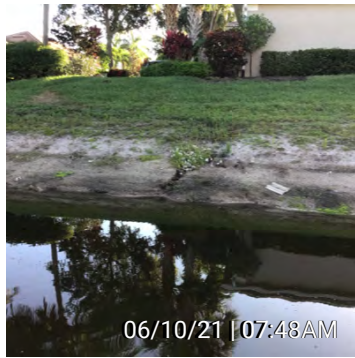
**51. Figure 51 - Washouts**  
Dan DiVincenzo | 07/08/21 | 03:39PM

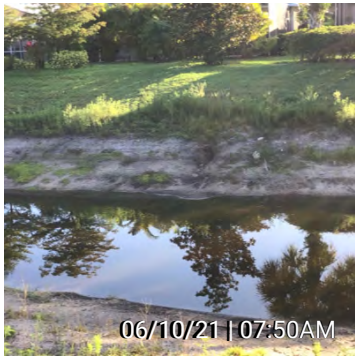
**52. Figure 52 - Washout (Recurring)**  
Dan DiVincenzo | 07/08/21 | 03:38PM

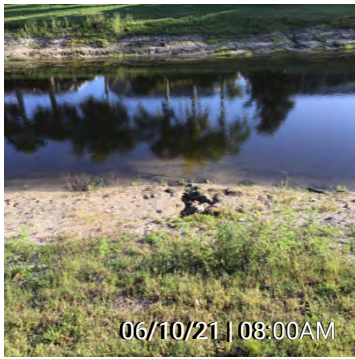
**53. Figure 53- Washout**  
 Dan DiVincenzo | 07/08/21 | 03:38PM

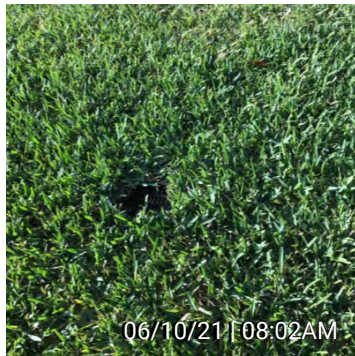
**54. Figure 54 - Washout from bubble up**  
 Dan DiVincenzo | 07/08/21 | 03:38PM

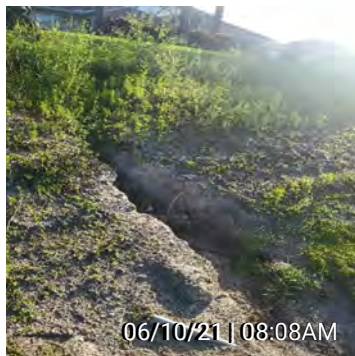
**55. Figure 55 - Washout**  
 Dan DiVincenzo | 07/08/21 | 03:38PM

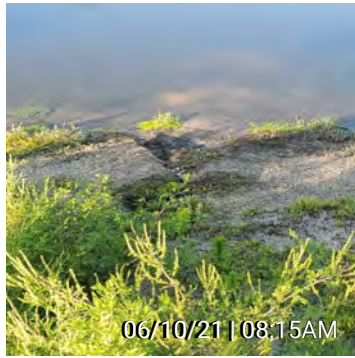
**56. Figure 56 - Washouts**  
 Dan DiVincenzo | 07/08/21 | 03:38PM

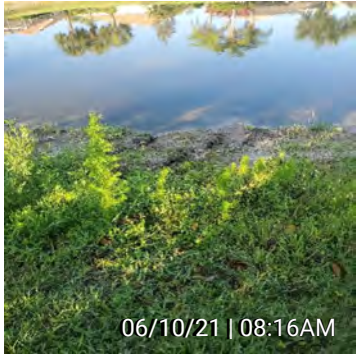
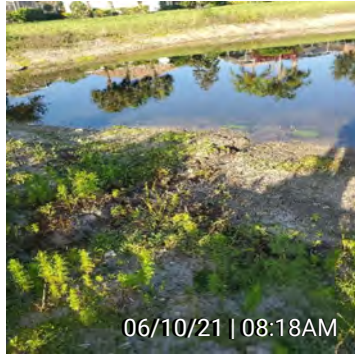
**57. Figure 57 - Washout (Recurring)**

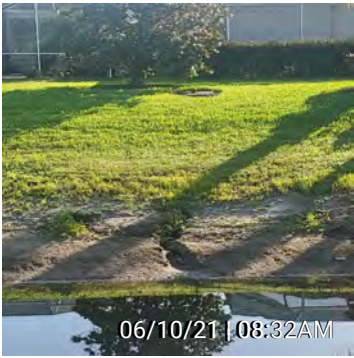
**60. Figure 60 - Washout**

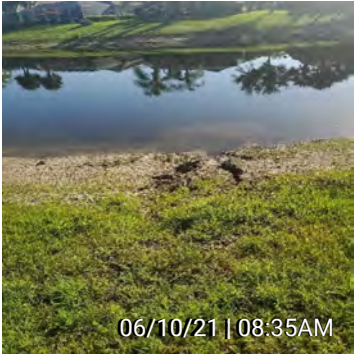
61. Figure 61 - Washout

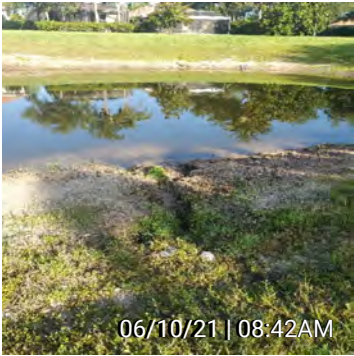
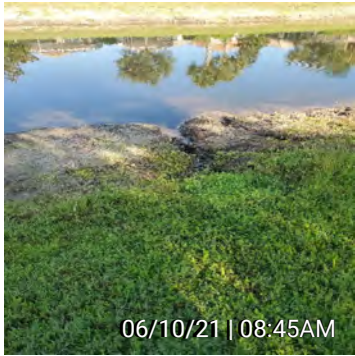
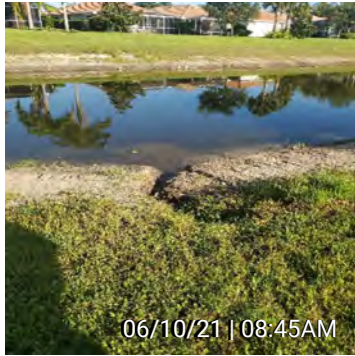
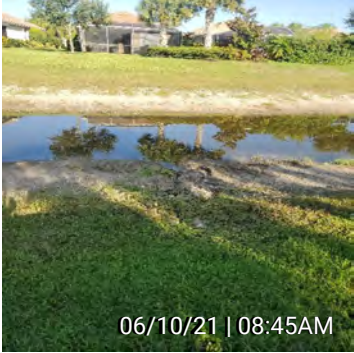
62. Figure 62 - Washouts throughout bank

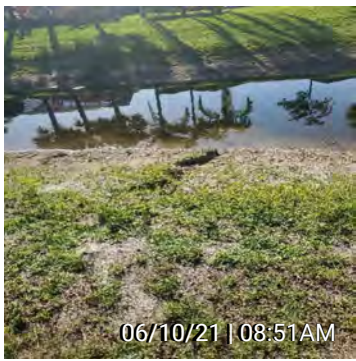
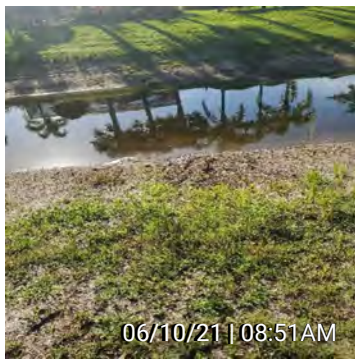
63. Figure 63 - Washouts

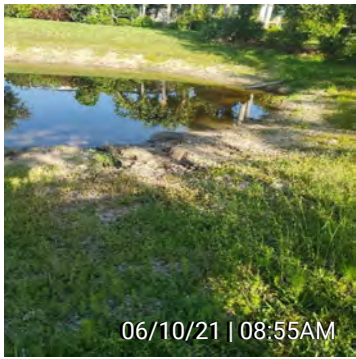
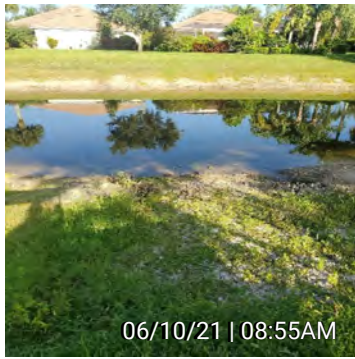
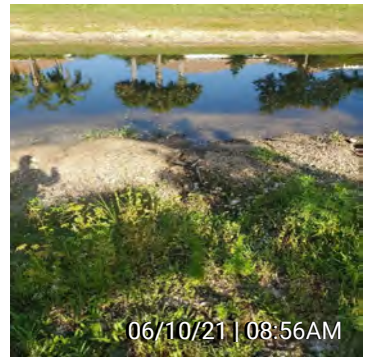
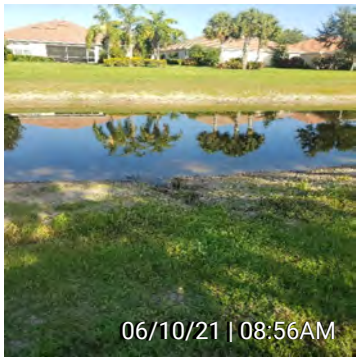
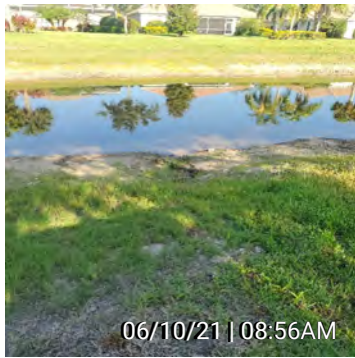
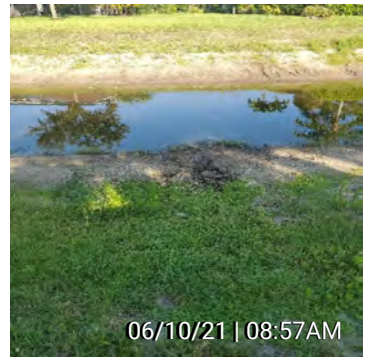
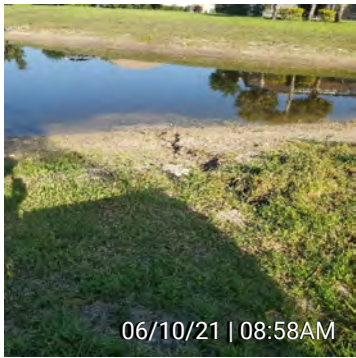
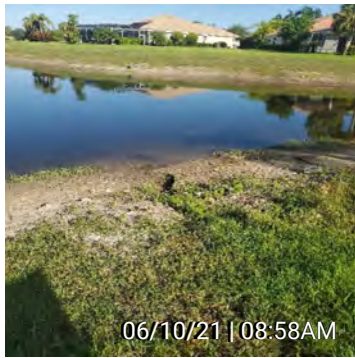
#### 64. Figure 64 Washouts

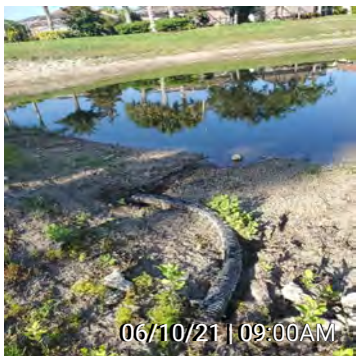
#### 65. Figure 65 - Roof drain causing bank washout

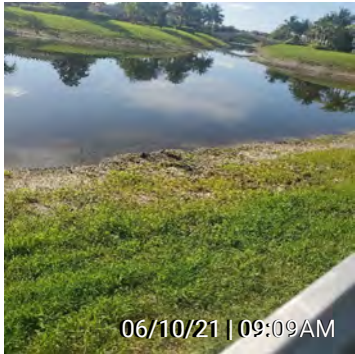
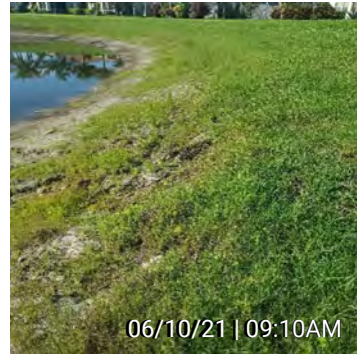
**67. Figure 67 - Washout caused by landscape island. Directing water to drop off greater than 9"**

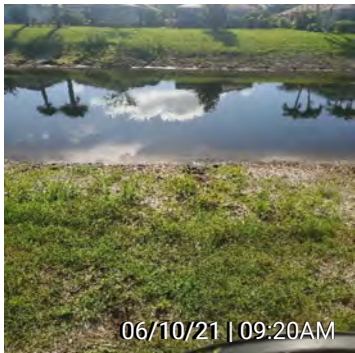
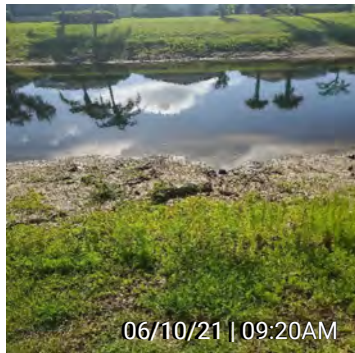
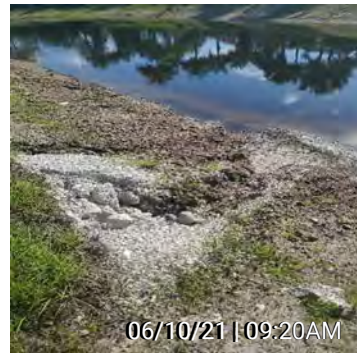
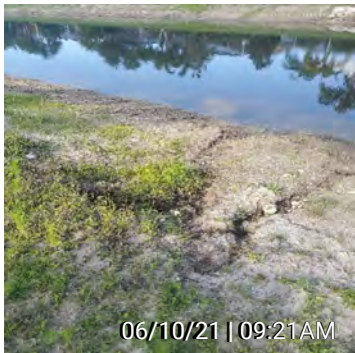
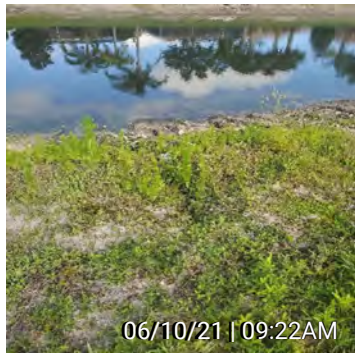
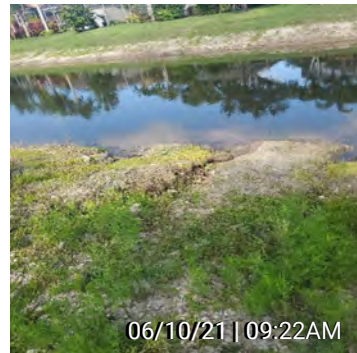
**68. Figure 68 - Washout with drop greater than 9"**

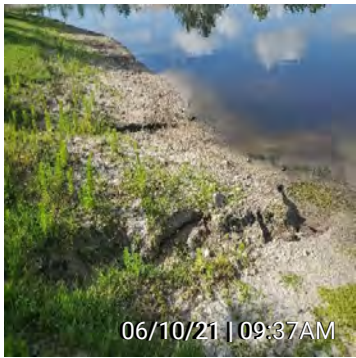
**71. Figure - 71 washout**  
Dan DiVincenzo | 07/08/21 | 03:30PM

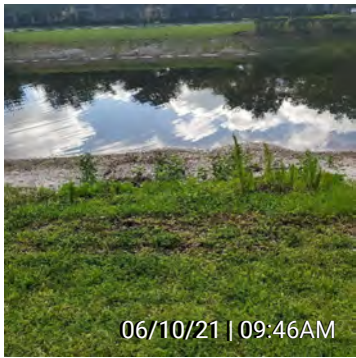
**72. Figure 72 - Washouts**  
Dan DiVincenzo | 07/08/21 | 03:30PM

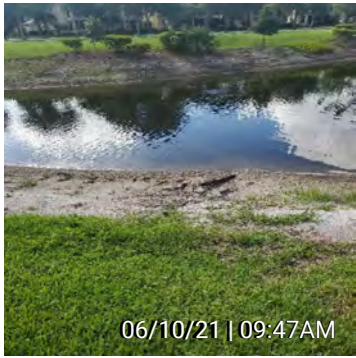
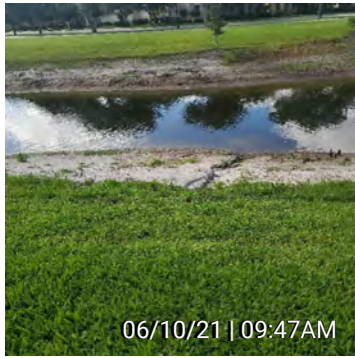
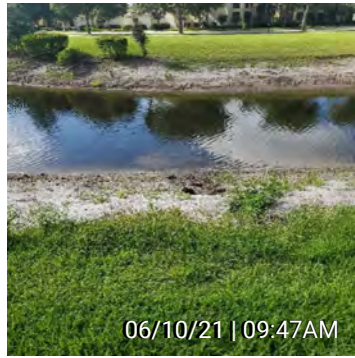
**73. Figure 73 - Washout**

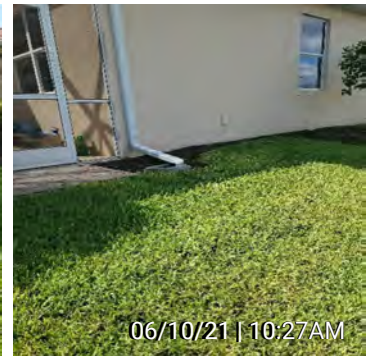
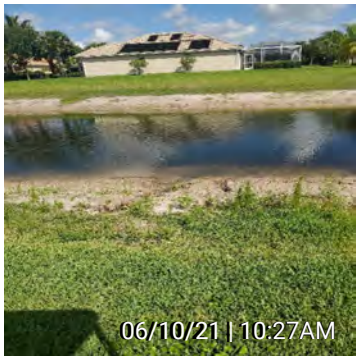
**75. Figure 75 - Washouts**

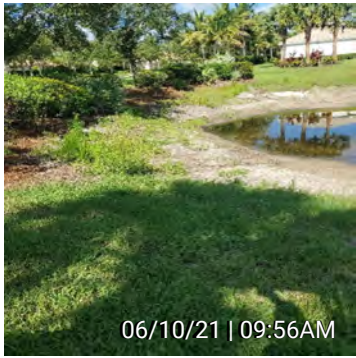
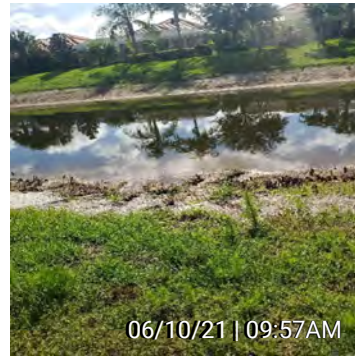
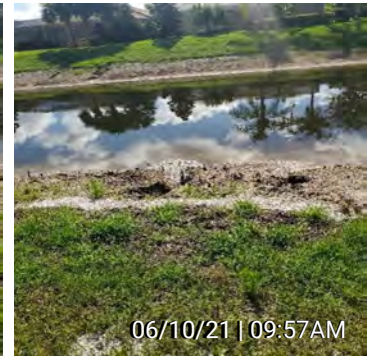
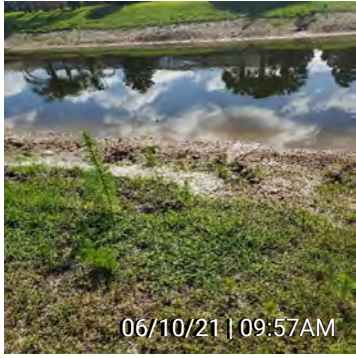
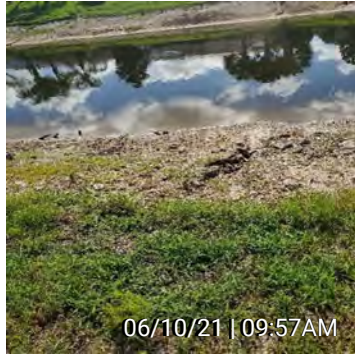
**76. Figure 76 - Washout**  
 Dan DiVincenzo | 07/08/21 | 03:22PM

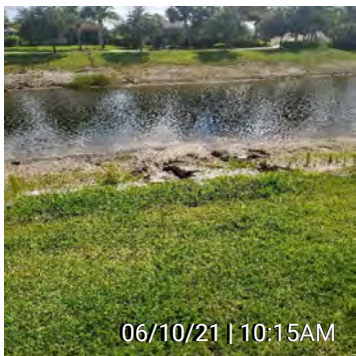
**77. Figure 77 - Washout**  
 Dan DiVincenzo | 07/08/21 | 03:20PM

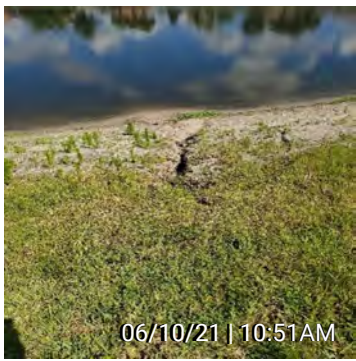
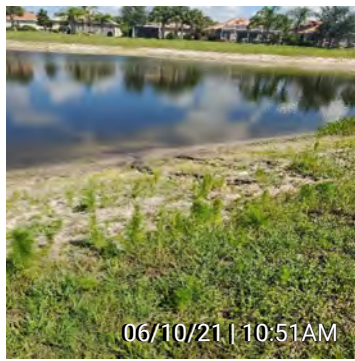
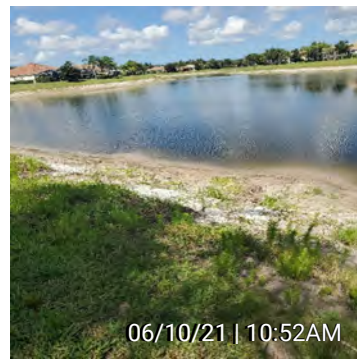
## 78. Figure 78 - Washout

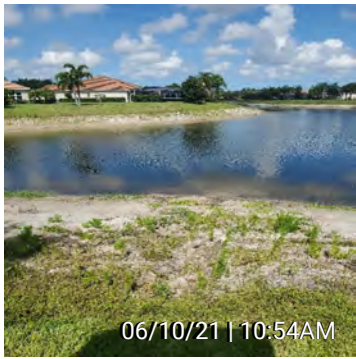
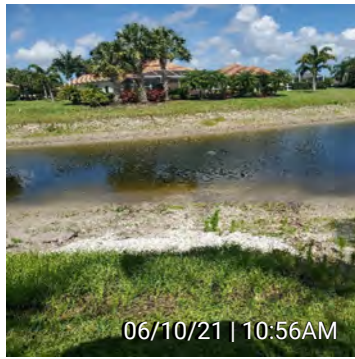
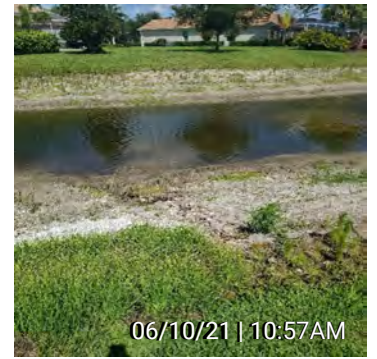
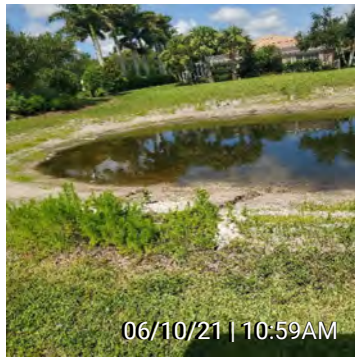
## 79. Figure 79 - Washout

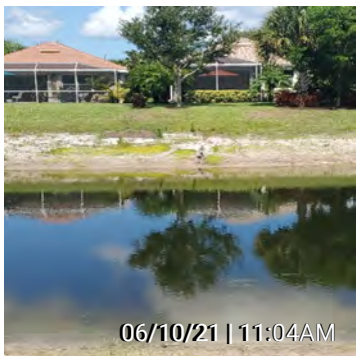
**80. Figure 80 - Washouts**

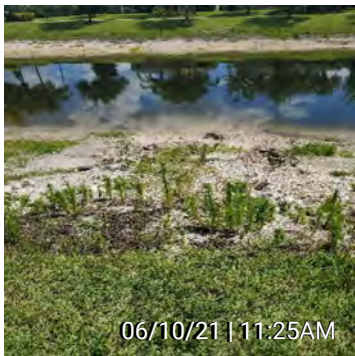
**83. Figure 83 Erosion**

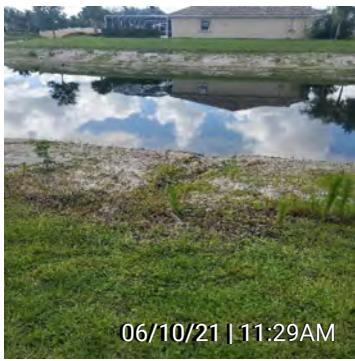
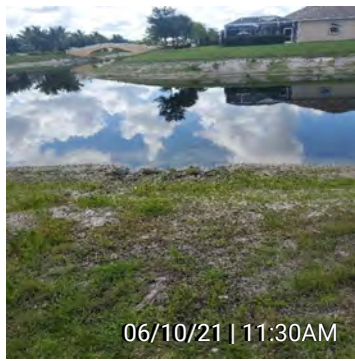
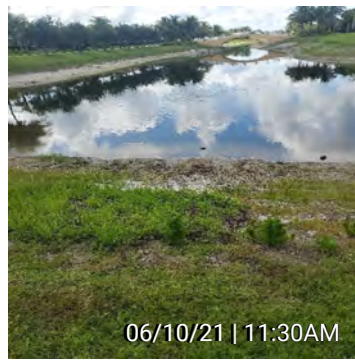
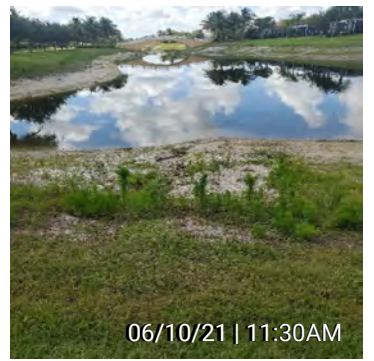
**84. Figure 84 - Erosion**

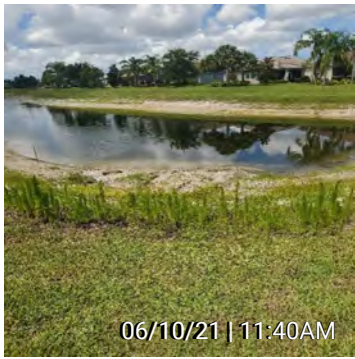
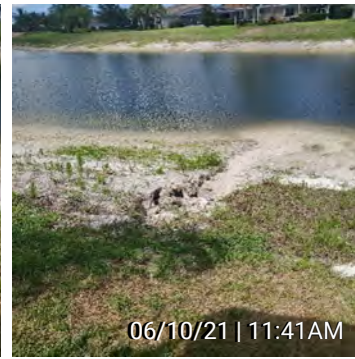
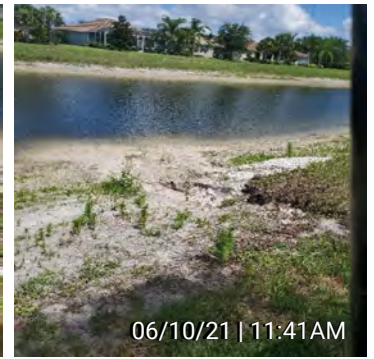
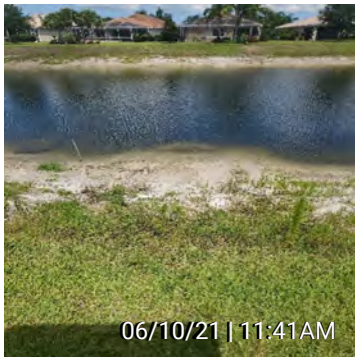
## 85. Figure 85 - Washout

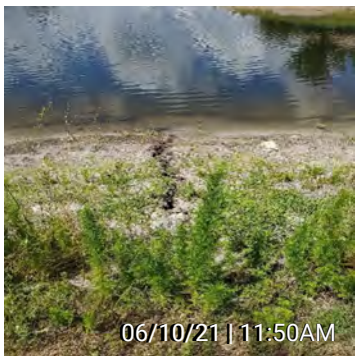
## 86. Figure 87 - Washouts

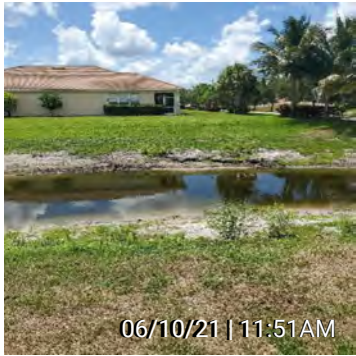
87. Figure 88 - Erosion

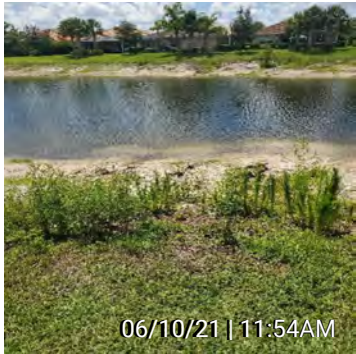
88. Figure 89 - Washouts

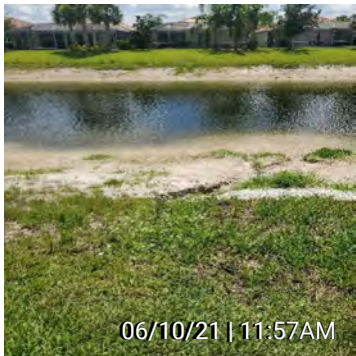
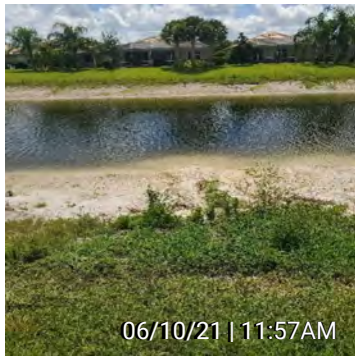
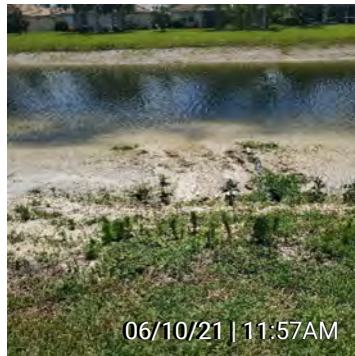
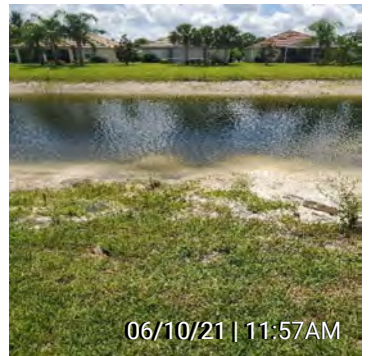
89. Figure 90 - Washouts

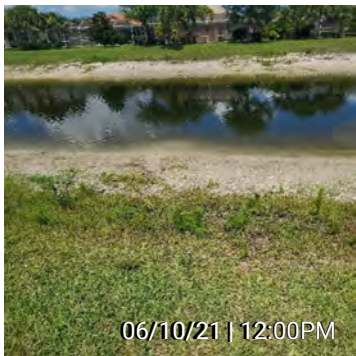
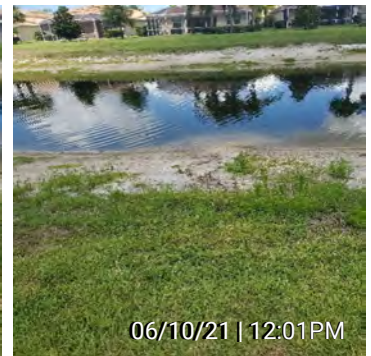
90. Figure 91 - Washouts

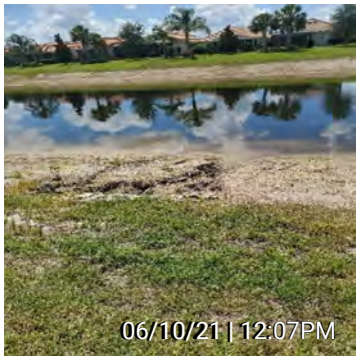
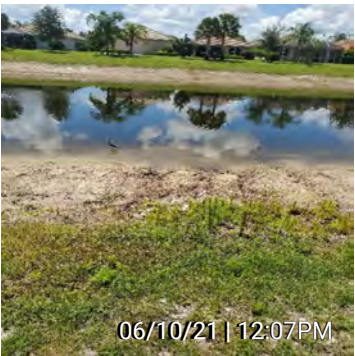
### 91. Figure 92 - Washouts

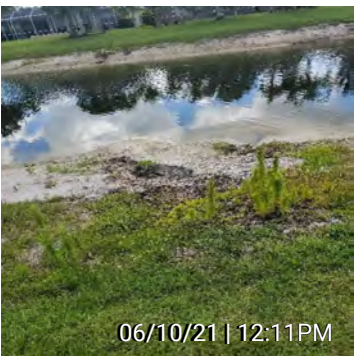
### 92. Figure 93 - Washouts

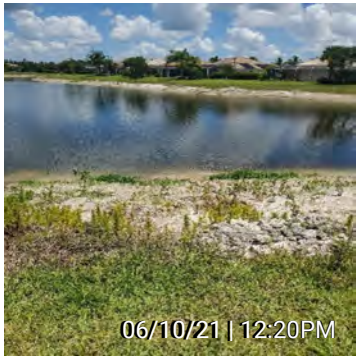
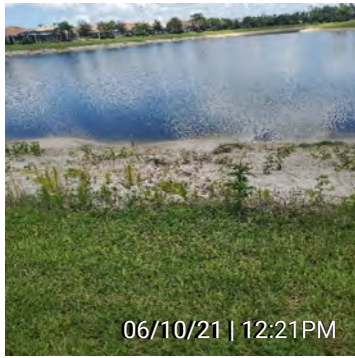
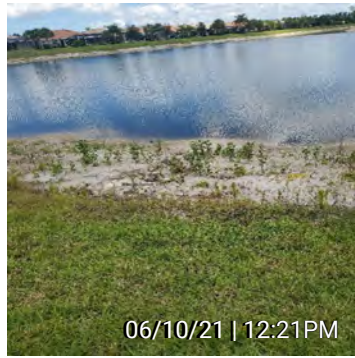
### 93. Figure 94 - Washout extend rip rap to waters edge

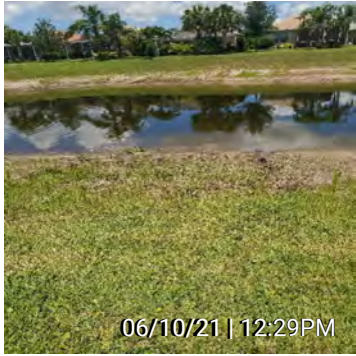
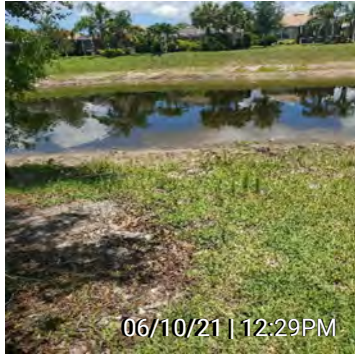
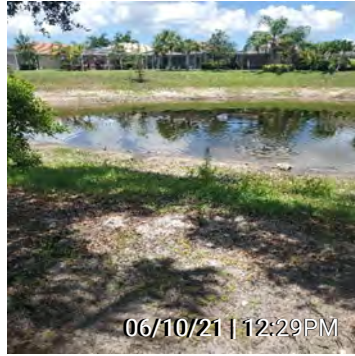
#### 94. Figure 95- Washout

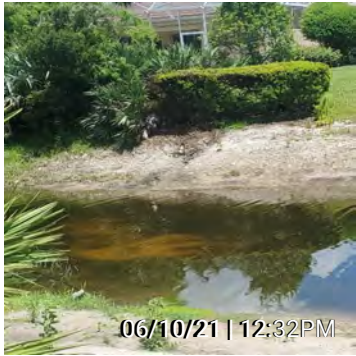
#### 95. Figure 96 - Washout

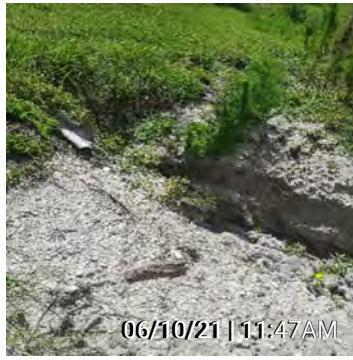
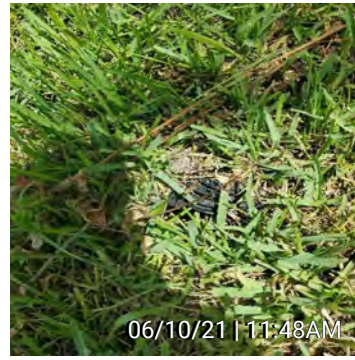
#### 1. Figure 86 - Blowout caused by drain - Potential Life Safety issue
